URGENT DEVICE CORRECTION

Problem Description Baxter Healthcare Corporation is issuing a voluntary Urgent Device Correction for AK98 dialysis machines due to two software issues.

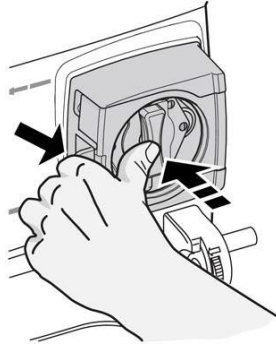
1. Make sure that the blood pump door is closed during the Function Check i.e. before “Green Fluid Path” is reached

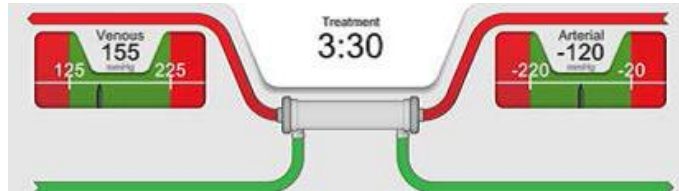
2. Wait to put on the blood lines and the dialyzer on the machine until the machine has reached Green Fluid Path.
