November 5, 2015

## IMPORTANT PRODUCT CORRECTION NOTIFICATION

### Temperature Monitoring Anomaly on VITROS® Systems Using Software Version 3.2 and Below (Immediate Action Required)

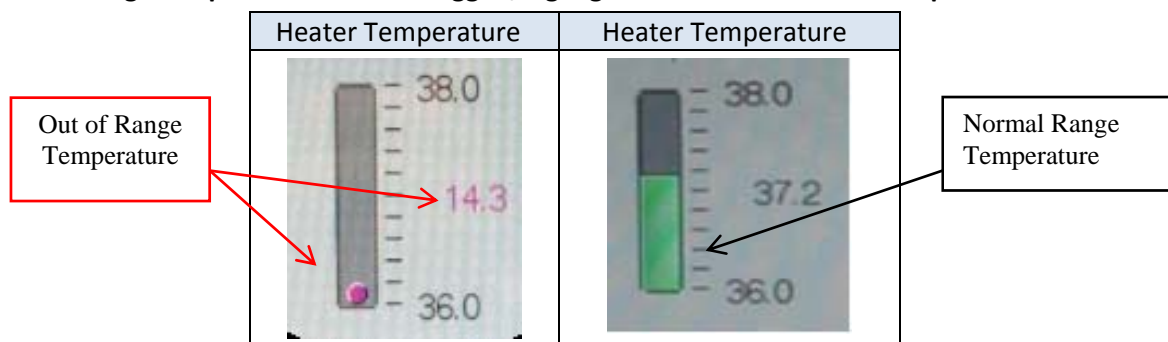
Out of range temperatures will be flagged/highlighted as shown in the example below

- If a temperature is out of range, and the status bar indicates that the system is "Ready" or the Temperature icon is not present:
  - Contact our Technical Solutions Center to report the occurrence
  - Follow the instructions on page two of this document to resume normal operation
- Review all results generated since the last time you verified the temperature following your normal lab procedures.

- Select '*Diagnostics*'
- Power **off** Circuit Breaker (CB) 14
- Power **on** Circuit Breaker (CB) 14, wait 20 seconds after the last PER-328 condition code occurs
- Exit '*Diagnostics*' to initialize the system
- Contact your Ortho-trained field service representative to resolve the Thermistor issue.
