April 8, 2016

URGENT PRODUCT CORRECTION NOTIFICATION

Potential Sample Metering Anomaly on VITROS® Systems using Software Version 3.2.2 and Below

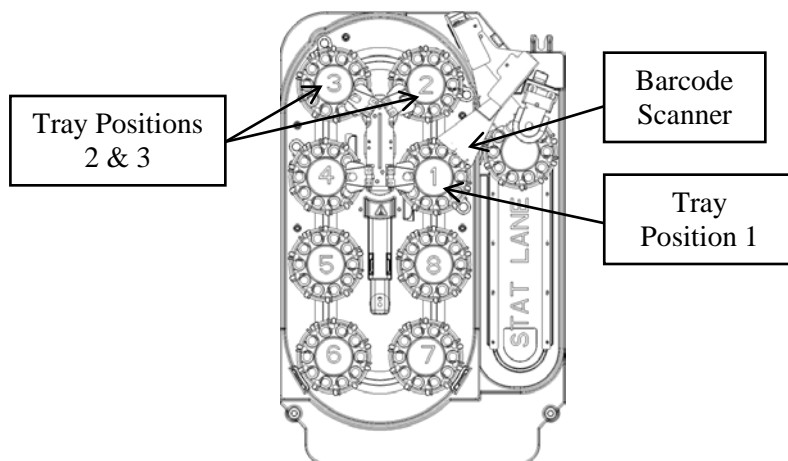
4. How can I determine tray positions in the Sample Supply?

Located within the Sample Supply, there are 4 sampling positions in the Routine Lane. The following *specific* sequence of events must occur in order for the software timing anomaly to happen:

1. A sample from a Universal Sample Tray in tray position 2 or 3 is in process or scheduled to be aspirated **and at the same time**,
2. A tray in position 1 is rotated to scan the tray and a condition code occurs (TD4-20C, TD4-20* and/or TD4-21*) **and**
3. System performs an auto recovery (i.e., initialization) for all trays in positions 1 -4.

The affected positions located in the Routine Lane of the Sample Supply as shown below:
