Medical Device Safety Notification

AFFECTED DEVICE: Alaris™ Pump Module 8100

21st March 2017

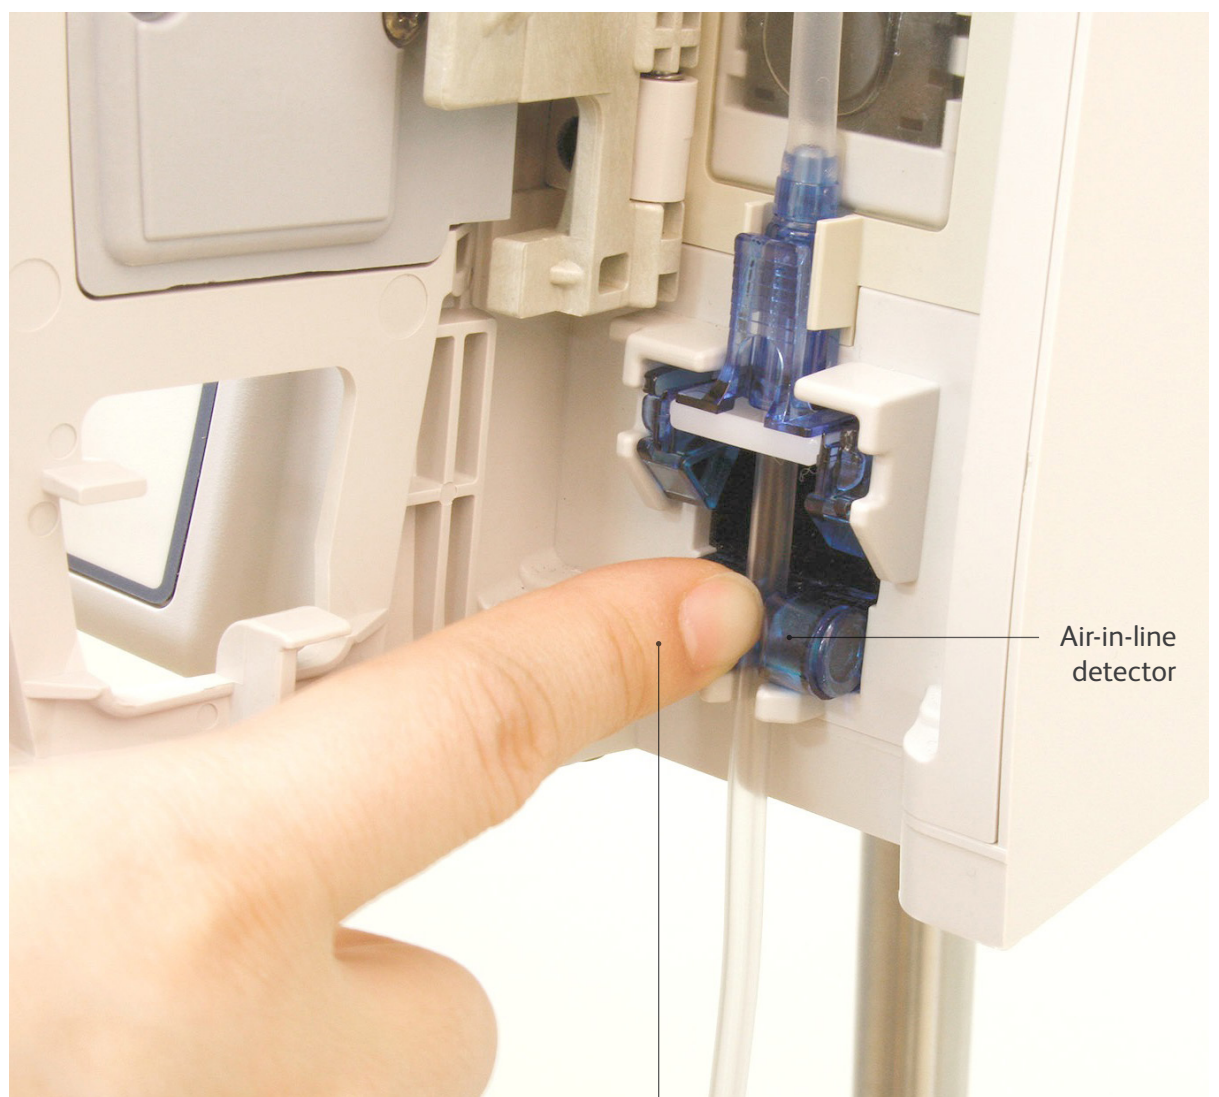
When loading the administration set into the Alaris™ Pump module, the tubing needs to be **pushed back into the air-in-line detector**. If it is not pushed back far enough, the air-in-line detector will sense air behind the tubing and alarm.

Use a fingertip to firmly push the tubing toward the back of the air-in-line detector.
