URGENT FIELD SAFETY NOTICE – BDDS-19-1617

BD Kiestra™ Inoqua™ / Inoqua+™

1 August 2019

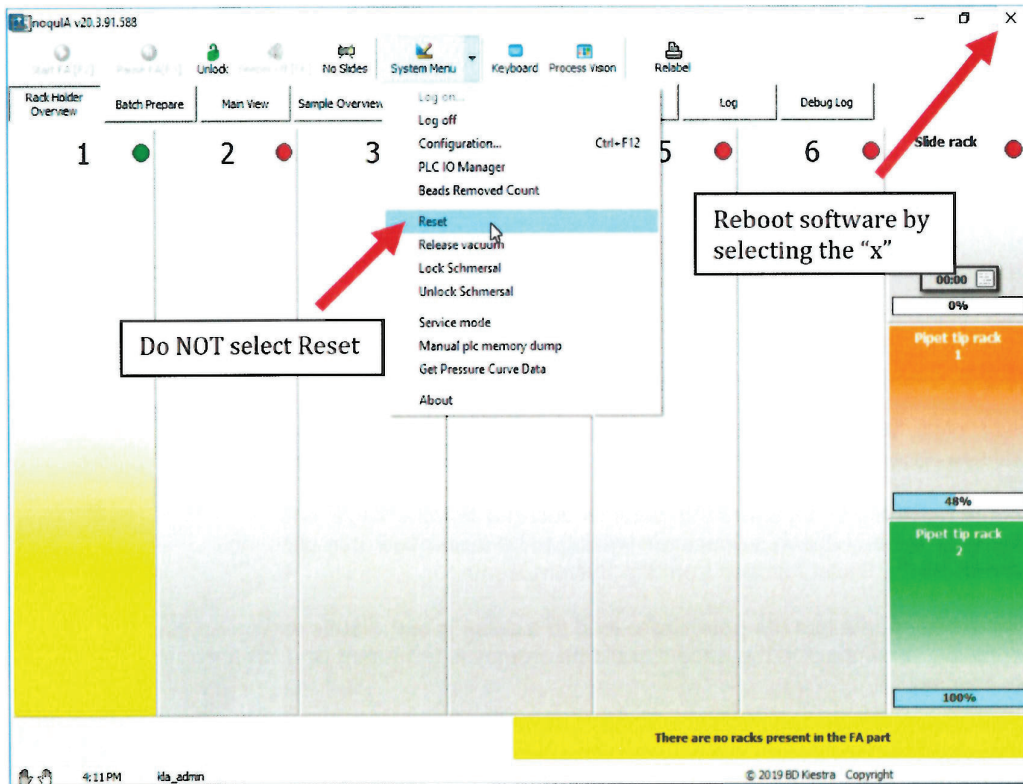
BD recently identified through a customer complaint investigation that an anomaly is present in Inoqua™ / Inoqua+™ software version 20.3. This software anomaly has the potential to cause a mismatch between a specimen and plate. While it has not been ruled out that the anomaly can cause a mismatch in other instances, BD has observed that the mismatch can happen when following conditions occur together:

- The Inoqua hardware is not operating, such as during a power outage, and
- the pipette has already drawn a specimen waiting to be dispensed on a plate, and
- the user selects the Reset function from the System Menu.

1. Do not utilize the Reset function from the System Menu of Inoqua™ software until further notice. Refer to the image on page 2.
2. In order to reboot the Inoqua™ software, close the Inoqua™ software application by selecting the "x" in the upper right corner. Refer to the image above. The Inoqua™ software can then be restarted by double clicking the Inoqua™ software's icon on the desktop.
3. Complete the attached Customer Response Form and return to the BD contact noted on the form so that BD may acknowledge your receipt of this notification.
