## Product Correction

Immediate Action Required

Product Name	List Number	UDI
ARCHITECT c4000 Cuvette Segment	02P75-01	Not applicable
ARCHITECT c8000 Cuvette Segment	01G46-01	Not applicable
ARCHITECT c16000 Cuvette Segment	09D32-05	Not applicable

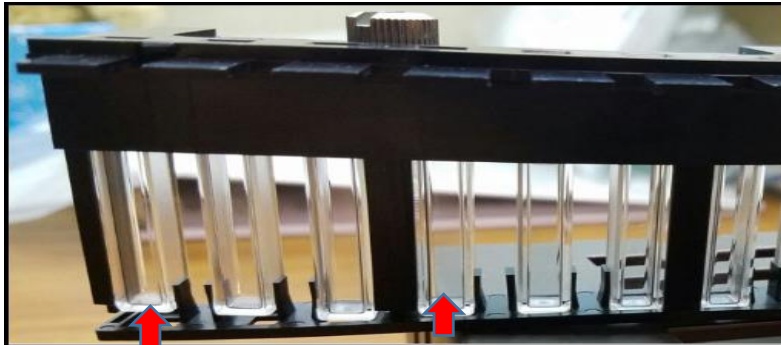
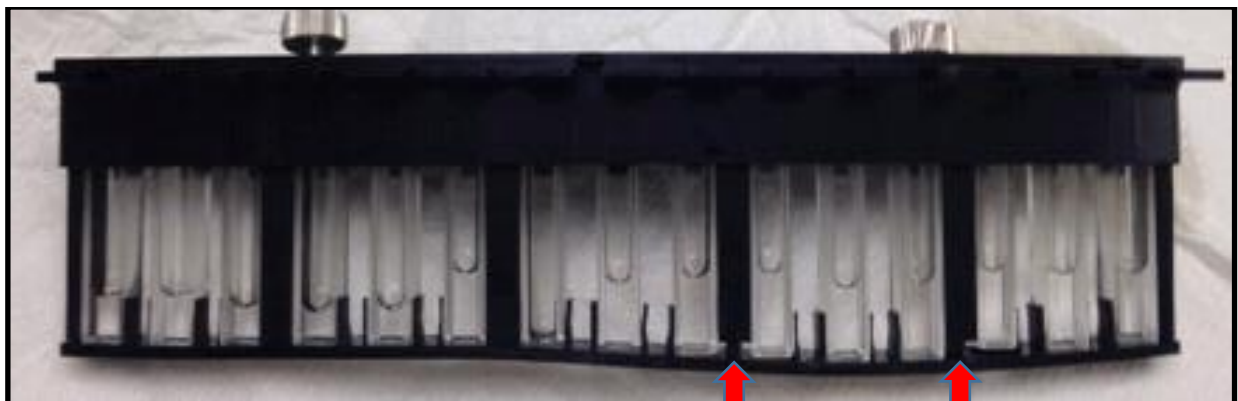
The base of the ARCHITECT Cuvette Segment may become detached under specific conditions. When a cuvette segment base is detached, cuvettes may be seated lower than the designed height. This may result in inadequate dispense into specific cuvettes due to the sample probe being unable to make efficient contact with the cuvette bottom.

- Excessive force applied during manual cleaning of cuvettes or cuvette wash tower crashes
- Lack of sufficient glue during cuvette segment manufacturing (c4000 and c8000 only)

The following pictures show examples of cuvette segments where the base is detached from the vertical support post.

*The red arrows indicate where the base has become detached from the vertical support posts*

If a cuvette segment with a detached bottom is identified, replace it before performing any additional testing on your ARCHITECT Clinical Chemistry System.

To remove the cuvette segments from the ARCHITECT for inspection, follow the procedure in ARCHITECT System Operations Manual Section 9 Service and maintenance, Component replacement, Replace a cuvette segment (c4000, c8000, and c16000). Wear gloves, as residual oil from an ungloved hand may cause imprecise optical reads. Once removed from the ARCHITECT, inspect each cuvette segment for damage by gently pulling downwards on the segment base at several points along the segment. If damage is discovered, replace the cuvette segment.
