IMPORTANT FIELD SAFETY NOTICE

CentriMag™ Acute Circulatory Support System Motor Model: 201-10002
Compatible with CentriMag™ Pump and PediVas™ Pump

September 5, 2018

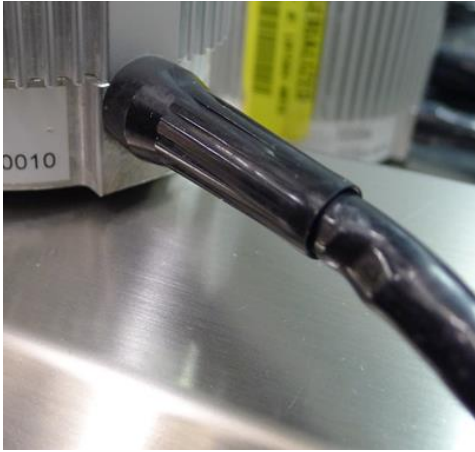
Our analysis of devices associated with the motor stop field complaints showed that the motor stop can be attributed to a break of a wire or short circuit between wires within the electrical cable where the cable exits the motor cable bend protection. This damage may be avoided by ensuring proper handling, such as avoiding tight bending of the cable, or winding the cable around the motor during storage during the life of the motor.

Figure 5: Cable Damage at the Motor Bend Relief

Before each use, verify that the cable connecting the Motor to the Console is not kinked, which can occur with improper handling such as wrapping the cable tightly around the Motor. If the cable is kinked, replace the Motor.

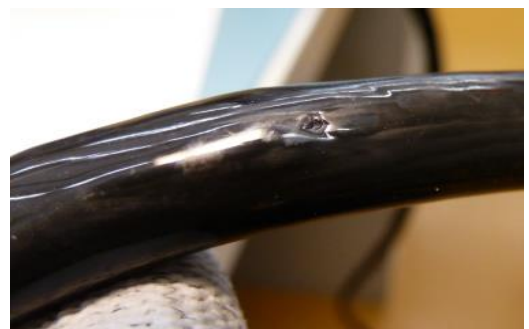
Figure 8: Damaged Motor Cable
