Product Correction

Urgent - Immediate Action Required

This Product Correction letter is to inform you of an issue with the ARCHITECT c Systems Mixer (LN 09D59-01, 09D59-02, and 09D59-03). There is the potential for the mixer blade, attached to the mixer with a screw and nut, to separate from the mixer. The missing mixer blade will result in inadequate mixing of the reaction mixtures leading to potential incorrect results (failed assay calibration, Quality Control (QC) out of range, and/or incorrect patient results). The impact on the test result may vary depending on the assay being performed and the viscosity of the patient sample.

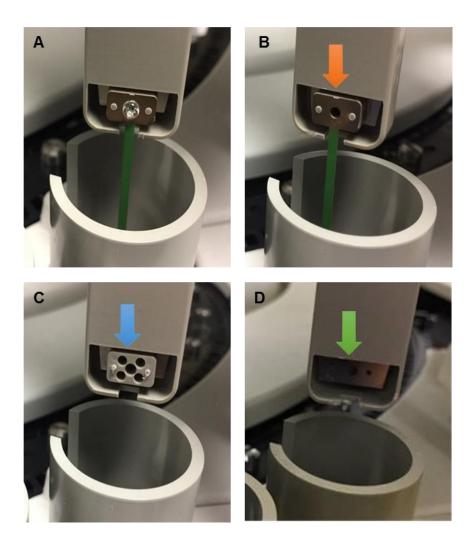
The following pictures show a A) normal mixer B) mixer missing the mixer screw (orange arrow pointing to missing screw), C) missing mixer blade with spacer shim present (blue arrow pointing to missing mixer blade), and D) missing mixer and spacer (green arrow pointing to missing mixer blade and spacer).

- 1. Replace broken mixer. Refer to Replace the Mixer (c4000, c8000, c16000)1.
- 2. Replace the cuvette dry tip. Refer to Replace the cuvette dry tip (c4000, c8000, c16000)1.
- 3. Follow the instructions in **Appendix C** to inspect all cuvettes to ensure that the screw or nut did not fall into an individual cuvette.
