Subject: **URGENT MEDICAL DEVICE RECALL CORRECTION NOTICE**

Affected Product: Tibial Alignment Guide – iAssist Knee System

Tibial Alignment Guide Part Number: 20-8011-013-00	Lot Numbers: 110623, 120265, 120659, 120659-1, 120793, 120793-1, 120794, 120794-1&2, 130134, 130135, 120431-1&2, 130539-A
--	---

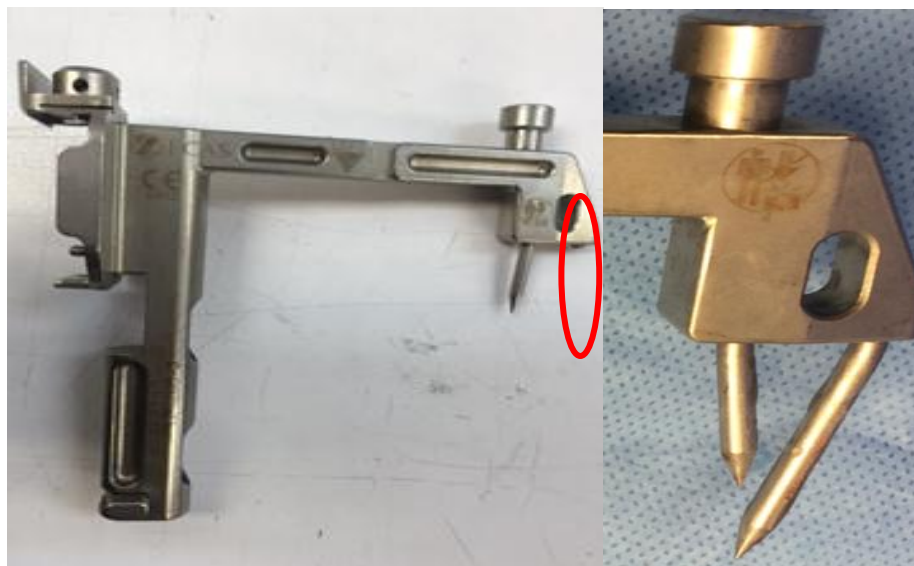
Based upon complaint investigation, Zimmer CAS has determined that the potential exists for the spikes on the iASSIST Tibial Alignment Guide to bend or break during insertion or extraction from the tibia during use. The bending or breakage of the spikes is due to a stress riser at the junction of the spike and the main body of the instrument in combination with the presence of repeated high cyclic bending stresses from the impaction method utilized. These stresses are significantly increased when the proper steps of the surgical technique are not followed. Although unlikely, if a spike breaks and goes unobserved, there is the possibility of a spike being left in the surgical site. There have not been any complaints for this instrument associated with a spike being left in a patient. Product manufactured after May 2014 is not affected as they have a different assembly method of the spike that reduces the risk of fatigue. The affected devices were distributed to the US from December 2012 through December 2013.

Figure 1: Missing spike

Figure 2: Bent spike

Zimmer is currently making preparations for repair/replacement activities to follow. This document is provided to alert all users of the potential issue and to highlight the proper usage of the instrument per existing surgical technique to minimize the chance of any failure pending a replacement unit. A separate recall removal notice will be issued with detailed instructions beginning in July 2015. **Your sales representative will be notified when a replacement is available. Do not return product at this time as part of this action.**

1. Please carefully review this letter and ensure users of the iASSIST Knee system at your facility have been informed of this notice.
2. During use, to minimize the chances of bending or breakage, please follow the iASSIST Surgical Knee technique, as highlighted below (Reference 97-9001-101-00).
3. Inspect the device before and immediately after use to confirm that the spikes are not bent or broken. Please keep Zimmer informed of any adverse events associated with this device or any other Zimmer product. Adverse events may be reported to Zimmer at cas-support@zimmercas.com along with the return any affected device(s).
4. Please complete and sign the attached Certificate of Acknowledgment and return it to CorporateQuality.PostMarket@zimmer.com.
