Medtronic International, Ltd. (Singapore Branch)

URGENT: MEDICAL DEVICE CORRECTION O-arm™ 1000 Imaging System BI-700-00027-XXX and BI-700-00028-XXX

22nd May 2019

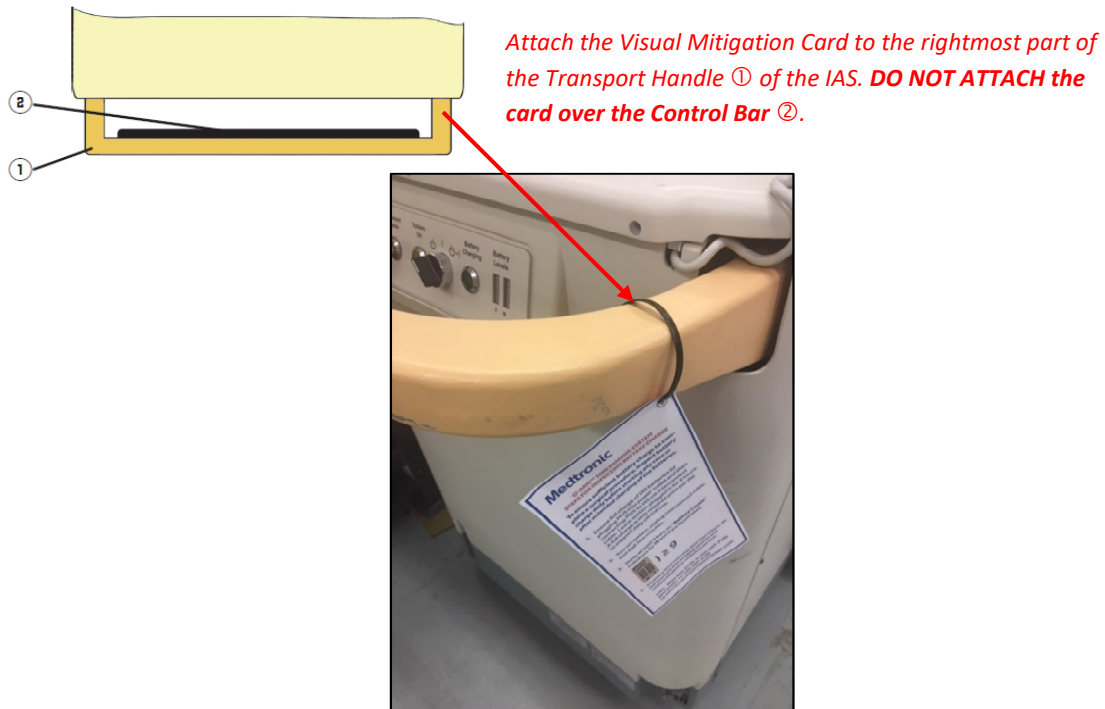
- 1) **Attach the *Visual Mitigation Card* to the IAS of your O-arm™ 1000 Imaging System, as illustrated in the image below, and follow the directions as noted.**

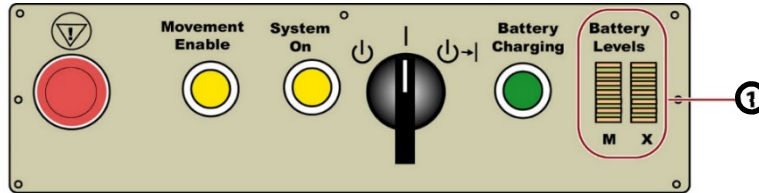
FIGURE 1

Battery Level Indicators: On the IAS Power Control Panel shown in Figure 1, the two columns of yellow LED lights (①) indicate the battery levels for the motion batteries (**M**) and the X-ray batteries (**X**). See “Battery Charge Level Indicators” in the user manual for more information about battery charge levels represented by the scrolling LEDs. See “User Performance Checks” in the user manual to ensure proper operation of the machine.

- While the Image Acquisition System (IAS) is turned on, unplug the interconnect cable and wait two minutes.
- Check the battery charge indicators on the power control panel.
- Verify that the **X** and **M** battery level indicators have at least 9 out of 10 bars illuminated to ensure sufficient battery charge to accomplish the procedure.
- If battery level indicates less than 9 bars, do not proceed with imaging session and contact Medtronic technical service: (800) 595-9709 or 720-890-3160 for US; +1-720-890-3160 for worldwide; or via email to RS.NAVTECHSUPPORT@MEDTRONIC.COM.

- While the Image Acquisition System (IAS) is turned on, unplug the interconnect cable and wait two minutes.
- Check the battery charge indicators on the power control panel.
- Verify that the **X** and **M** battery level indicators have at least 9 out of 10 bars illuminated to ensure that the battery chargers and batteries are recharging properly.
- If battery level indicates less than 9 bars, do not proceed with imaging session and contact Medtronic technical service: (800) 595-9709 or 720-890-3160 for US; +1-720-890-3160 for worldwide; or via email to RS.NAVTECHSUPPORT@MEDTRONIC.COM.
