Urgent Medical Device Correction **For All Claria MRI™ CRT-D SureScan™ and Amplia MRI™ CRT-D SureScan™**

December 2016

Issue Description

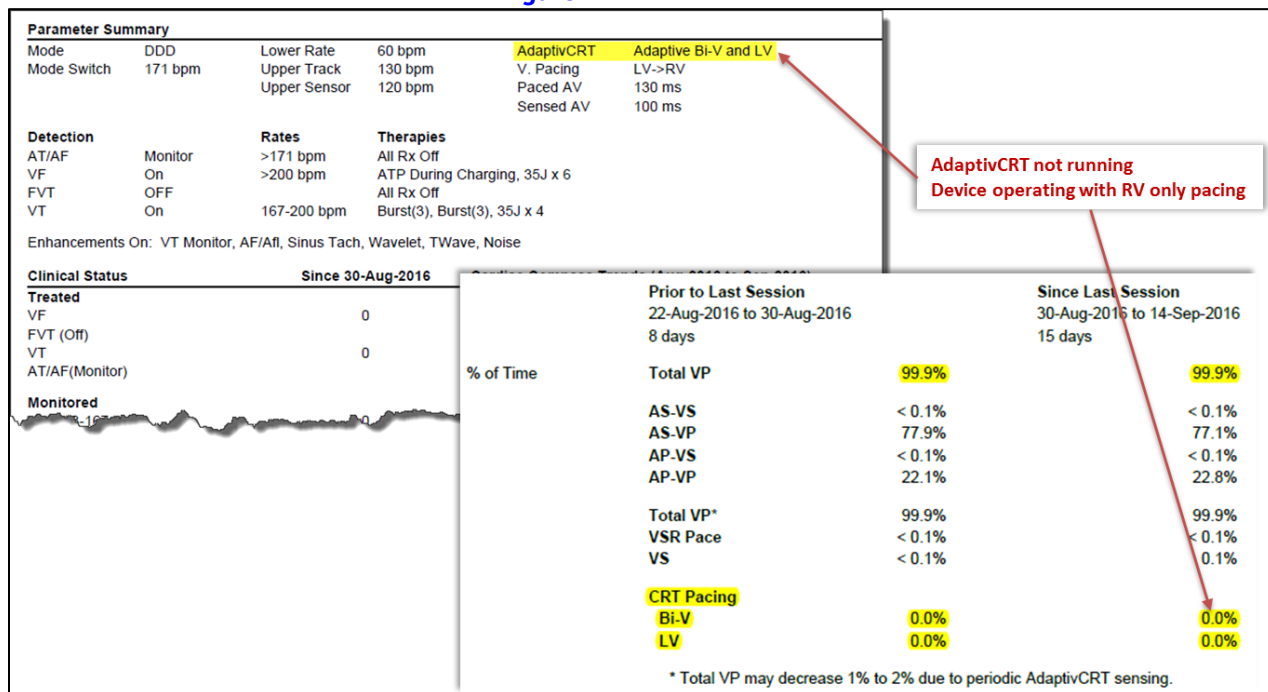
<Figure 1>

When a patient with AdaptivCRT enabled (shipped setting) is subsequently programmed to MVP mode and then re-programmed back to DDD or DDDR, AdaptivCRT is not re-enabled. When this programming sequence occurs, LV pacing is not delivered, despite parameters indicating AdaptivCRT is enabled (Appendix A, Figure 1). This will result in RV only pacing, which may be undesirable for the patient. LV pacing will remain disabled until a specific programming sequence is manually completed; refer to the Patient Management section of this letter (Appendix A) for details.

- If the CRT setting is currently programmed to *Adaptive Bi-V and LV* or *Adaptive Bi-V* (Figure 1), review rate histogram CRT Pacing percentages (CRT Pacing: Bi-V and LV).
- If Bi-V and LV pacing percentages *Since Last Session* are both near 0%, then the device has encountered the programming sequence and has lost LV pacing; proceed to step 2.

- Select the CRT parameter window, select *Nonadaptive CRT*, and select *PROGRAM*.
- Select the CRT parameter window, select the desired AdaptivCRT setting (*Adaptive Bi-V and LV* or *Adaptive Bi-V*), and select *PROGRAM*.
