Issue Impact Assessment (IIA)

Title: DxTerity™ Mislabel Issue

Document #: 10772055DOC

Executive Summary

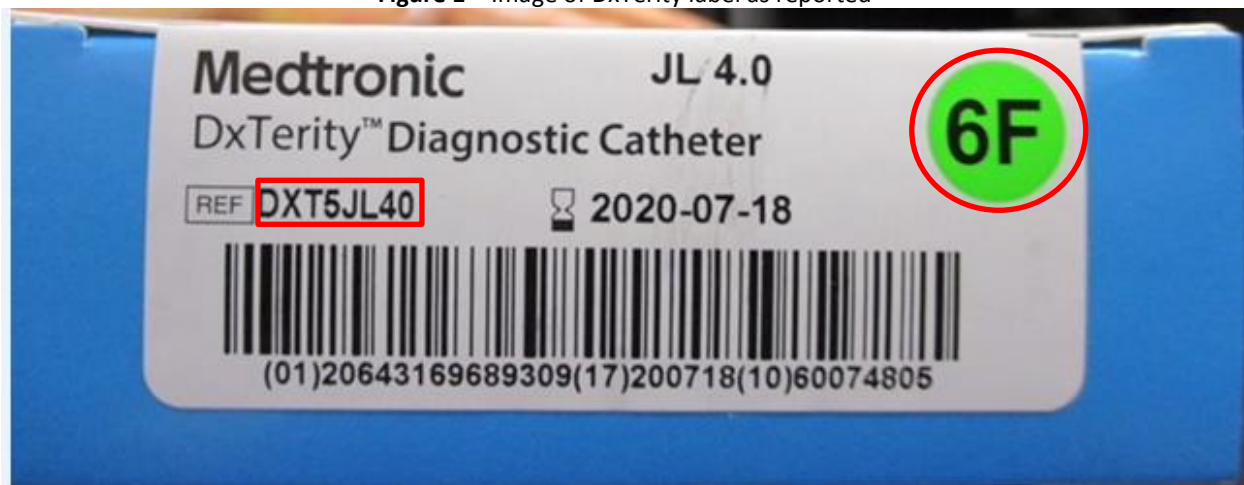
Figure 1 – Image of DxTerity label as reported

All 6 complaints were received from Germany. All 6 complaint devices are being returned. A root cause investigation is in the process of being completed. Based on the root cause investigation performed so far, it is likely that an operator issued the correct label stock (5F) in the ERP but physically used the incorrect stock (6F) during manufacturing of DxTerity lot 60074805. CAPA PR 379804 has been opened to further investigate the root cause and document corrective actions.

On February 7, 2018, Medtronic was notified by two accounts of a 5F DxTerity catheter (item DXT5JL40 – 5F Judkins Left 4.0 curve) with a green 6F indicator on the carton label (see figure 1). As a 5F item, the French size indicator should be a grey 5F indicator. Complaints PE 0702353420 and PE 0702355495 were initiated.

- The catheters inside in the carton are the correct DXT5JL40 item and all other information and configuration details are correct.

FCA number CVG-18-Q4-17 will be initiated to retrieve the impacted product lot 60074805 from the field.
