Urgent: Medical Device Correction

Single Chamber Temporary External Pacemaker 53401

All Serial Numbers Distributed February 2017- November 2017

21 June 2018

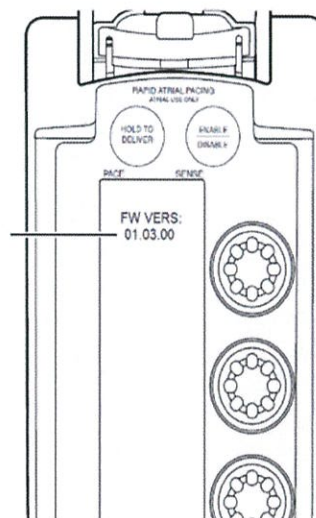
During power up process, Firmware Version will be displayed for 2 seconds

FIGURE 1- updated firmware displayed in this image

1. Verify whether 53401 EPGs in your possession are affected (See Appendix A: Serial Number List).
2. If your EPG is affected, complete the following:
 - Determine if the EPG firmware has been updated.
 - Power unit on and view firmware version (Figure 1 below).
 - If firmware version is 01.03.00 or greater, EPG firmware has been updated with correction for this issue. Continue to Step 3 to confirm that you were informed of the issue. No other action is recommended.

If firmware version is 01.02.00, EPG firmware has not been updated. You may arrange to have your Medtronic Service Center update the EPG firmware at no charge.
3. Please complete the attached Confirmation Form in its entirety and return it as directed to confirm your receipt and understanding of this information. You must complete this form even if all units in your inventory have the correct firmware version.
