URGENT MEDICAL DEVICE REMOVAL**29901 CareLink Encore™ Programmer Power Supply Model 26907**
(See Appendix A for List of Programmer Serial Numbers)

January 2019

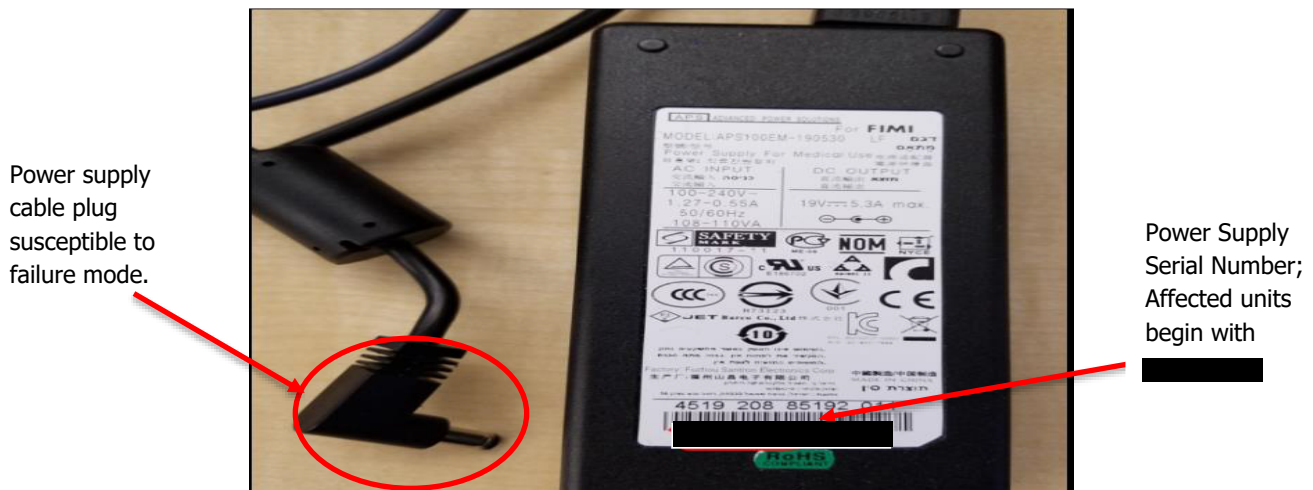
FIGURE 1

This letter is to inform you of the potential for an electrical short circuit to develop in a subset of 479 Model 26907 power supply cable plugs that connect to the Medtronic Model 29901 CareLink Encore programmer. A failure mode of the power supply has been found where an electrical short occurs on the low voltage direct current connector and results in the connector heating up, generating smoke, melting and in some cases disconnecting from the programmer. Note that Encore programmers are designed with a battery back-up power source which can support programmer operations with at least 20 minutes of power prior to shutting down the programmer.

The affected power supplies were potentially packaged with a subset of Model 29901 CareLink Encore Programmers distributed in the US, India and specific countries in Europe, and the Middle East. Each affected power supply has a serial number beginning with [REDACTED] (refer to Figure 1). The potential for an electrical short circuit to develop in the cable plug is specific to this subset of power supplies. Encore programmer power supply units outside of the identified serial number list are not in scope of this advisory and will not be replaced. Model 26907 power supplies are not compatible with other Medtronic programmers (e.g. CareLink™ Programmer Model 2090).

Your local Medtronic representative will take responsibility for identifying and replacing any affected power supply with a new unit and will notify you when the action has been completed.

- Discontinue use of any power supply immediately if you observe overheating, smoke or melting near and around the power supply cable plug to the programmer (refer to Figure 1). Notify your local Medtronic representative or Medtronic Technical Services to report the observed failure.
