**MEDICAL DEVICE
CORRECTION**
CFx Longevity Estimator Software Error

Affected Programmers & Remote Monitoring Software Apps	Affected Devices
2090 CareLink™ Programmer 29901 Encore™ Programmer CareLink Network Application Software 2491 CareLink SmartSync™ Device Manager MyCareLink Heart™ Mobile Application	Subset of the following devices: Claria MRI™/Amplia MRI™/Compia MRI™/Viva™/Brava™ CRT-Ds Visia AF™/Visia AF MRI™/Evera™/Evera MRI™/Primo MRI™/Mirro MRI™ ICDs Azure™/Astra™ IPGs Percepta™/Serena™/Solara™ CRT-Ps Micra™ TPS

10 October 2019

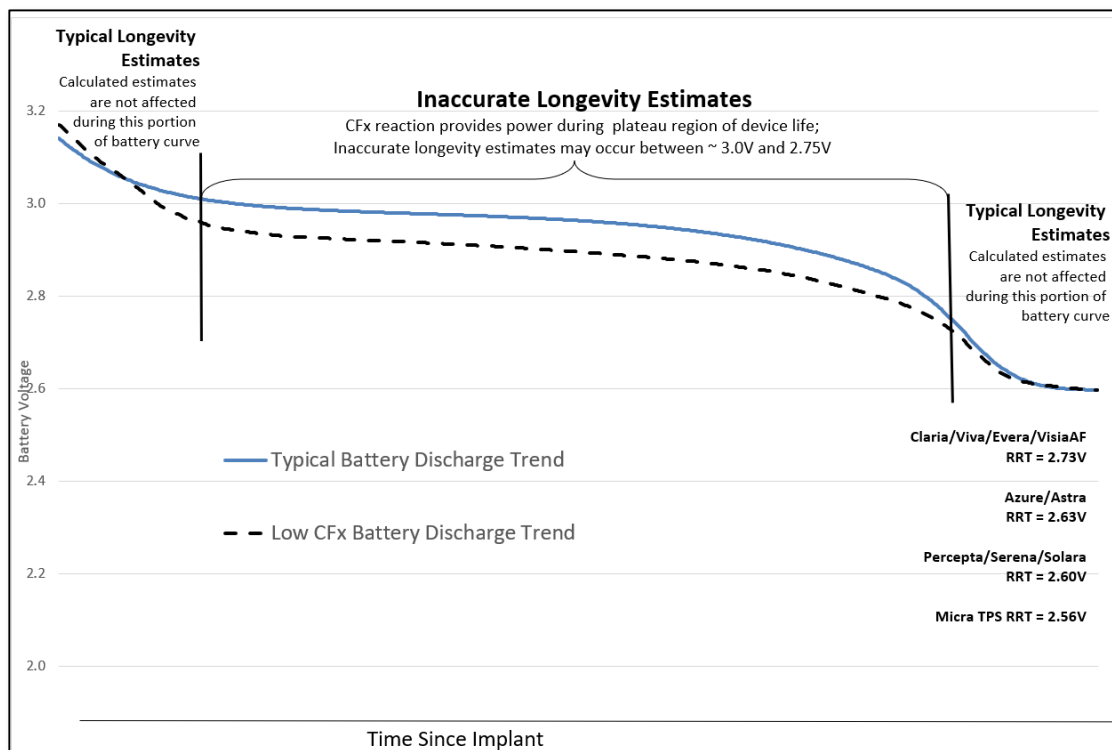
The inaccurate longevity estimation is limited to a well-defined subset of devices manufactured between October 2018 and April 2019, and only occurs in the middle (plateau) phase of the device life, as illustrated in the graph below. Approximately 53,100 devices worldwide, out of 1.23 million distributed or sold from the identified device families, are susceptible to displaying inaccurate longevity.

The cause of the inaccurate longevity estimate is a slightly lower-than-typical discharge voltage during the plateau phase of the battery depletion curve (dashed line), compared to a typical voltage plateau (solid line), as illustrated in the graph below. During this plateau period, the Carbon Monofluoride (CFx) in the battery cathode is powering the device. Note, longevity estimates early after implantation and later in the device life are unaffected, as shown below. The battery remains within operating specifications.

Software updates to programmers and remote monitoring systems are under development to correct for the inaccuracy in longevity estimates. Medtronic is targeting regulatory approval and release of the software updates to begin in mid-2020. Once available, Medtronic will inform you of the availability of the software and work with you to install the software onto clinic and hospital programmers. Software updates to individual patient devices will not be necessary to correct this issue, since longevity estimation resides on the programmers, mobile app and the CareLink Network.
