MEDICAL DEVICE CORRECTION

O-arm™ O2 Imaging System

November 15, 2019

MEDICAL DEVICE CORRECTIONFollow-Up to November 15, 2019 Notification
O-arm™ O2 Imaging System

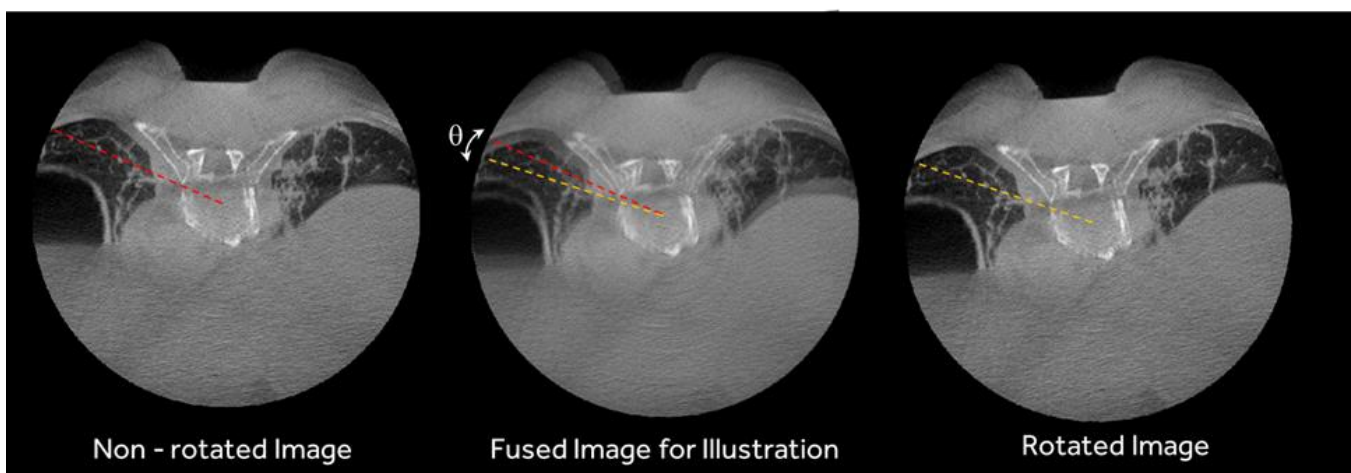
Medtronic has determined through internal testing that there is a potential for navigational inaccuracy when utilizing the O-arm™ O2 Imaging System's auto-registration feature, when used in conjunction with an Image-Guided Surgery System for a specific set of O-arm™ O2 Imaging System serial numbers. A list of potentially affected systems is provided in Table 1 of this letter. Due to loosening of an internal motor drive belt over extended number of uses, image rotation may occur relative to patient positioning data. Inaccuracy may occur when the O-arm registration information is transferred to an Image-Guided Surgery System to be used in navigation, utilizing the rotated images.

The O-arm™ O2 Imaging System is a mobile x-ray system designed for 2D fluoroscopic and 3D imaging and is intended to be used where a physician benefits from 2D and 3D information of anatomic structures and objects with high x-ray attenuation such as bony anatomy and metallic objects. Medtronic has determined that if the gantry tractor motor drive belt loosens over extended number of uses, it can result in rotation of 3D images about the gantry isocenter. While the 3D image is anatomically accurate within the image itself and may be used to confirm therapy, its electronic registered location may be rotated relative to the actual physical position of the patient. As a result, navigated positions may be inaccurate, with the magnitude of inaccuracy becoming more significant further away from isocenter.

If this image rotation due to a loose motor belt were to occur when auto-registration is used, it could lead to potentially significant navigational inaccuracies that may or may not be detected by the user through direct observation. The issue can be detected through navigational accuracy verification on the Image-Guided Surgery System. Unrecognized navigational inaccuracy may potentially result in serious injury.

Ensure that when you are using auto-registration, follow the recommendations described under the section titled “Use of Images in Image-Guided Treatments” on page 21 of the O-arm™ O2 Imaging System User Manual (IFU):

Warning: Frequently confirm navigational accuracy and system responsiveness during live navigation. Use the probe to touch bony anatomical landmarks and confirm that the locations identified on the images match the locations touched on the patient. Failure to verify the landmark locations on the image match the landmark locations on the patient may result in inaccurate navigation. If accuracy degrades, re-register the patient.

Warning: Abort usage of the O-arm™ O2 Imaging System and contact Technical Services if images are unintentionally rotated or smeared.

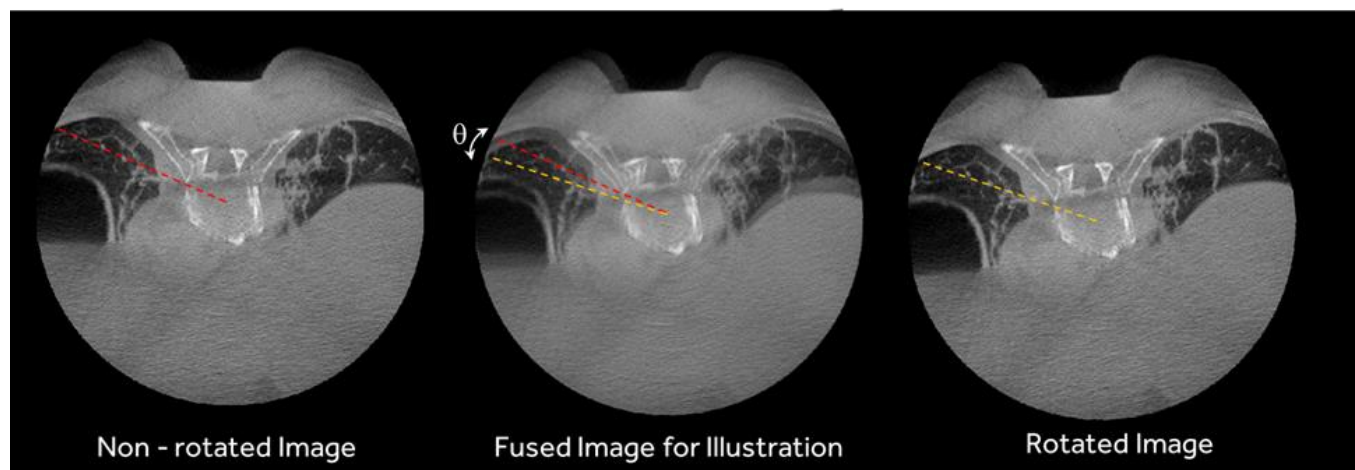
Medtronic has determined through internal testing that there is a potential for navigational inaccuracy when utilizing the O-arm™ O2 Imaging System's auto-registration feature, when used in conjunction with an Image-Guided Surgery System, for a specific set of O-arm™ O2 Imaging System serial numbers. A list of potentially affected systems is provided in Table 1 of this letter. Due to loosening of an internal motor drive belt over an extended number of uses, image rotation may occur relative to patient positioning data. Inaccuracy may occur when the O-arm registration information is transferred to an Image-Guided Surgery System to be used in navigation, utilizing the rotated images.

The O-arm™ O2 Imaging System is a mobile x-ray system designed for 2D fluoroscopic and 3D imaging and is intended to be used where a physician benefits from 2D and 3D information of anatomic structures and objects with high x-ray attenuation such as bony anatomy and metallic objects. Medtronic has determined that if the gantry tractor motor drive belt loosens over an extended number of uses, it can result in rotation of 3D images about the gantry isocenter. While the 3D image is anatomically accurate within the image itself and may be used to confirm therapy, its electronic registered location may be rotated relative to the actual physical position of the patient. As a result, navigated positions may be inaccurate, with the magnitude of inaccuracy becoming more significant further away from the isocenter.

If this image rotation due to a loose motor belt were to occur when auto-registration is used, it could lead to potentially significant navigational inaccuracies that may or may not be detected by the user through direct observation. The issue can be detected through navigational accuracy verification on the Image-Guided Surgery System. Unrecognized navigational inaccuracy may potentially result in serious injury.

Medtronic has determined that replacement of the internal O-arm gantry tractor motor drive will resolve the issue of increased potential for loosening of the drive belt in the population of affected O-arm™ O2 Imaging Systems.

Your local service representative will contact you to schedule replacement of the tractor motor drive. In the meantime:
