RE: Revised URGENT MEDICAL DEVICE CORRECTION for 3.0T 6 Channel Flex Coil Fails Surface Coil
Temperature Test.
GEHC Ref#60888

GEHC Ref# 60888

RE: 3.0T 6 Channel Flex Coil Fails Surface Coil Temperature Test

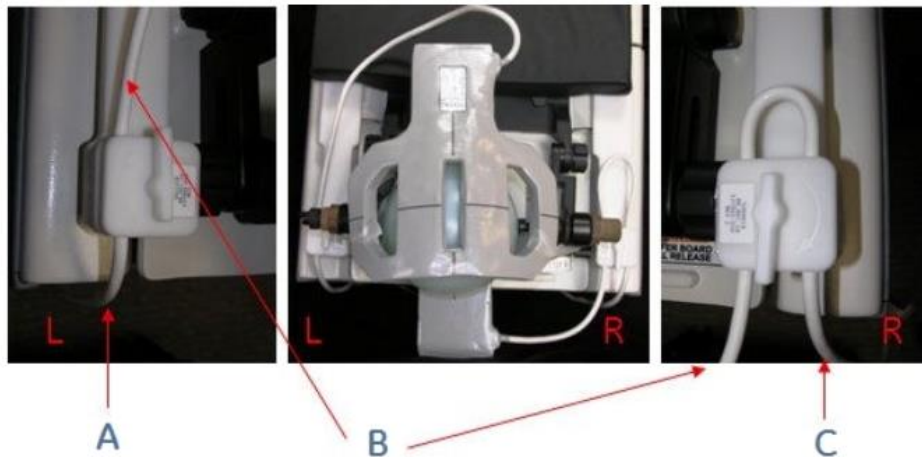
Coil overheating can occur when the device is used in Mode 2 setup. This could lead to a serious patient thermal injury. There have been no injuries reported as a result of this issue.

The issue is observed during the Mode 2 setup, as described in the “6-Channel Flex coil” section of the Surgical Suite operator manual (excerpts provided below).

Figure 3-55: Mode 2 – top coil with coil cable exiting toward patient's feet: left cable to MRI (A), to coil (B), and right cable to MRI (C).

1. Discontinue placing coil cables exiting toward the patient’s feet.
2. Discontinue use of Mode 2.

You can continue use of Mode 1.

GE Healthcare will correct all affected products at no cost to you. A GE Healthcare representative will contact you to arrange for the correction.
