**Field Safety Notice**

**Connection Lead SP (12V) for Infusomat Space, Infusomat Space P and Perfusor Space**

Article Number	Article Name	Batch
8713231	Connection Lead SP (12V)	CW 40/17 to CW 43/18

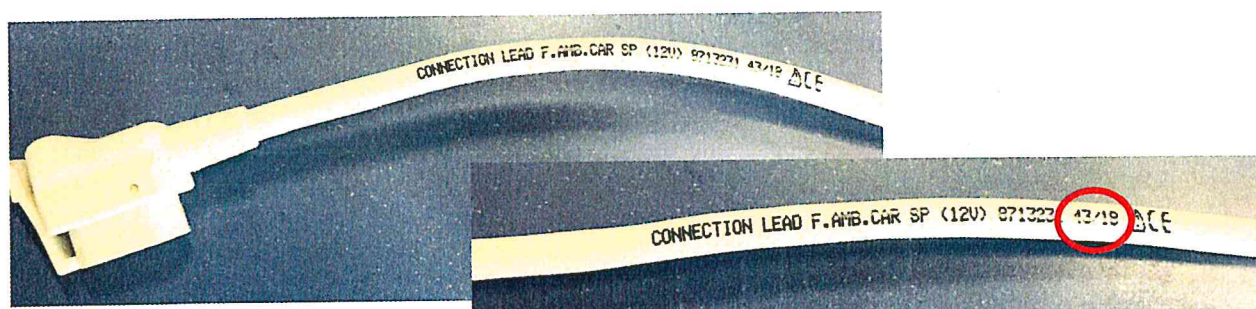
Figure 2 Indication of production date

Affected Connection Leads have been manufactured by our supplier in the period from October 2017 until September 2018. The production date is indicated as week and year (WW/YY), and is specified on the pump connector ending of the cable (see figure 2 below). The affected Connection Leads were produced between CW 40/17 and CW 43/18.

- For exchange of affected Connection Leads, please contact your local sales representative for further information on availability and replacement.
