# Field Safety Notice

## SBN-RPD-2015-020

RPD / Point of Care Handheld Platform  
Version 3  
29-Jan-2016

## Handheld Platform – USB Communication Data Loss

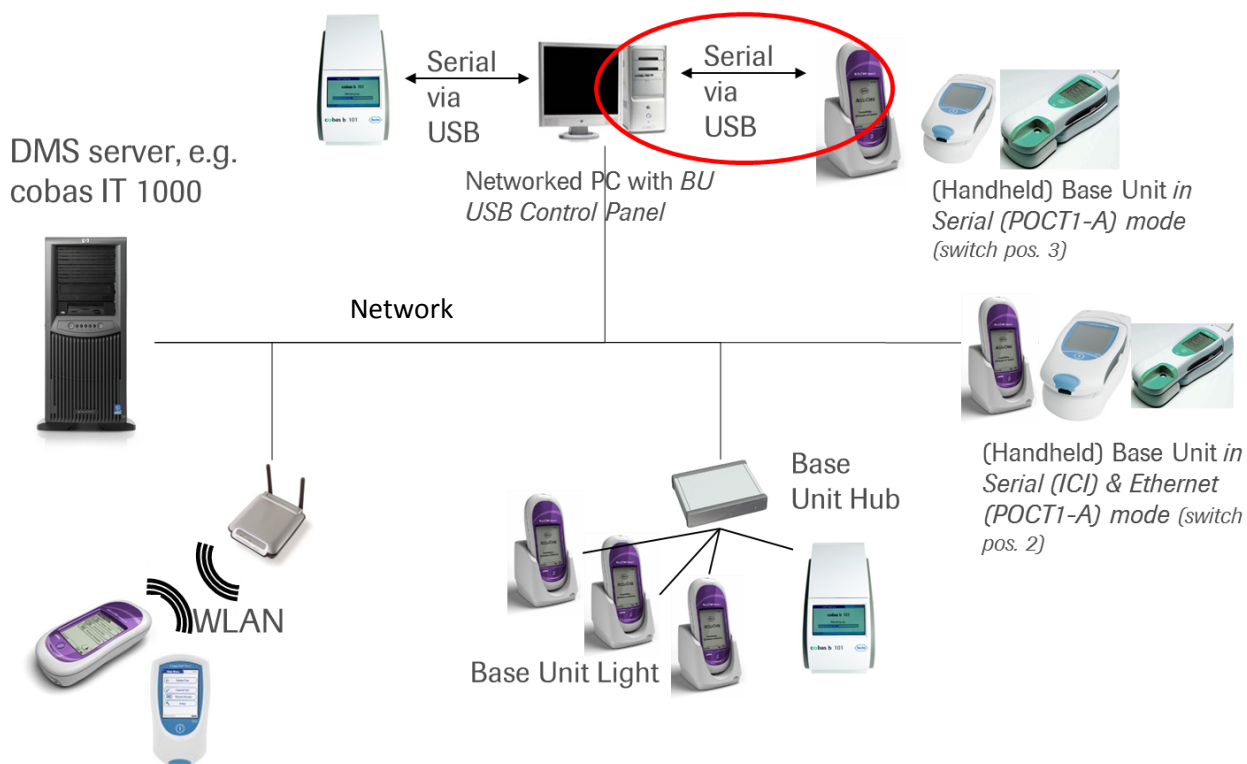
There are various connectivity options for Handheld Platform meters (Accu-Chek Inform II, CoaguChek Professional). Please refer to the graphic below.

Only the connection via USB to a PC is affected by this issue.

Communication via Ethernet (Local Area Network, LAN; Wide Area Network, WAN) or wireless local area network (WLAN) is not affected.

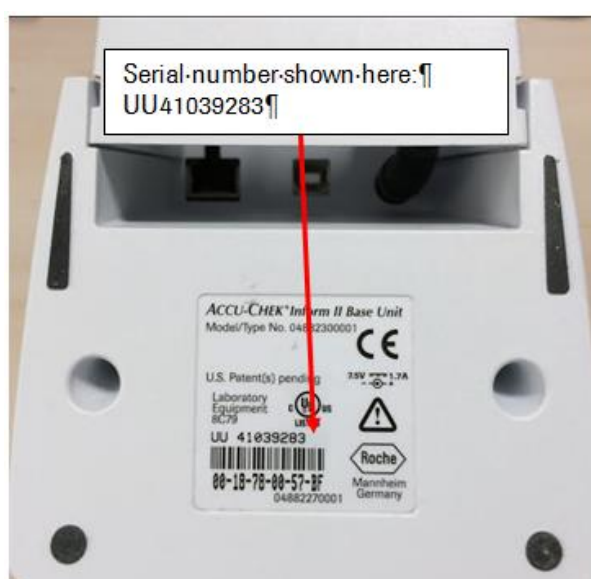
For Accu-Chek Inform II Base Units:

NOTE: You can identify the affected base units by the serial number that can be found on the back label of the Accu-Chek Inform II Base Unit and/or the Handheld Base Unit:
