Field Safety Notice

SBN-CPS-2016-007

Partly Damaged AssayTips in Certain Lots of AssayTip/AssayCup

Product Name	AssayTip/AssayCup
GMMI / Part No	12102137001
Device Identifier	
Production Identifier (Lot No./Serial No.)	15908113 15909113 15910113 16751113 16752113 16753113 16754113 16755113 16756113 16761113 16779113 16791113
SW Version	Not applicable
Type of Action	Field Safety Corrective Action (FSCA)

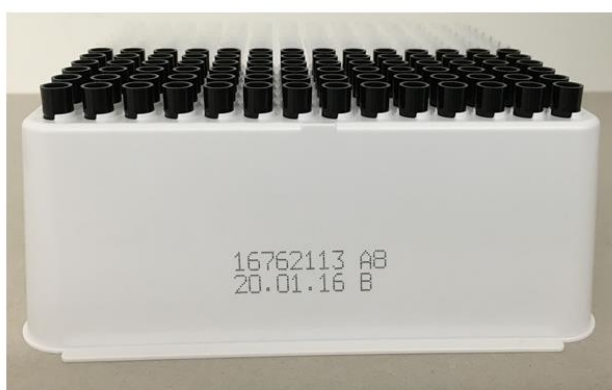
The affected lots can easily identified, see pictures below of the AssayTip/AssayCup tray and package:

- In case if you have any of the affected lots please discard them immediately locally.
