# Field Safety Notice

## SBN-CPS-2016-015

### Measurement Timing Error 7002: 108000572

| <b>Product Description</b> | <b>cobas c</b> 111 analyzer |

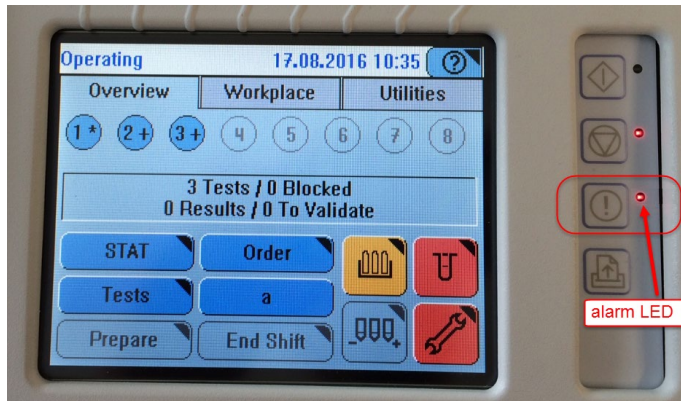
In case the LED shines red / the alarm button on the right hand side of the instrument becomes red (Fig. 1 / 1.1), the operator has to act as described in the respective operator's manual (section 'Reacting to alarm messages').

**Fig 1:** General overview of the display, global action buttons and LEDs.

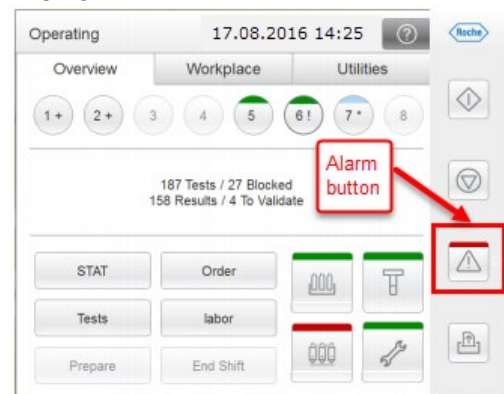
**Fig 1.1:** General overview of the display and global action buttons.

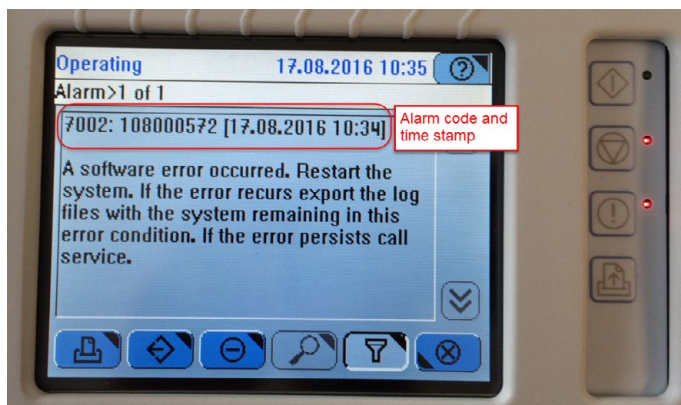
The timing error is indicated by the alarm code “7002: 108000572” incl. its timestamp:

**Fig 2:** Detailed alarm message on instruments with old screen versions.

Whenever the here reported error “7002: 108000572 A software error occurred” (Fig 2 / 2.1) is listed in the message list the following procedure shall be applied:

1. Review the timestamp of the error message (see Fig 2 / 2.1)
2. Review the samples being processed since that exact time (Fig. 3 and 4 / 3.1 and 4.1)

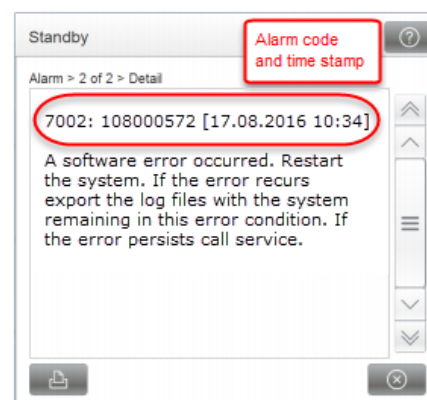
**Fig 2.1:** Detailed alarm message on instruments with 8.4” displays.

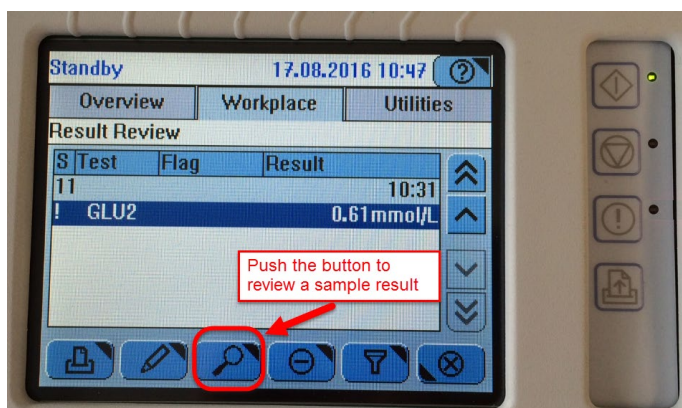
- the time stamp of result generation of sample 11 GLU2 is 10:46
- the error occurred at 10:34
- the result of 0.61 mmol/L for GLU2 might be affected and should be re-tested

**Fig 3:** Result Review window on instruments with old screen versions.

All samples processed since this time stamp need to be re-measured.

3. Restart the system
4. Re-measure all the tests of respective samples in order to guarantee absence of potentially erroneous results

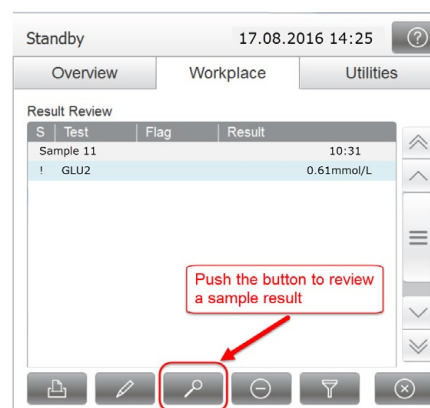
**Fig 3.1:** Result Review window on instruments with 8.4” displays.

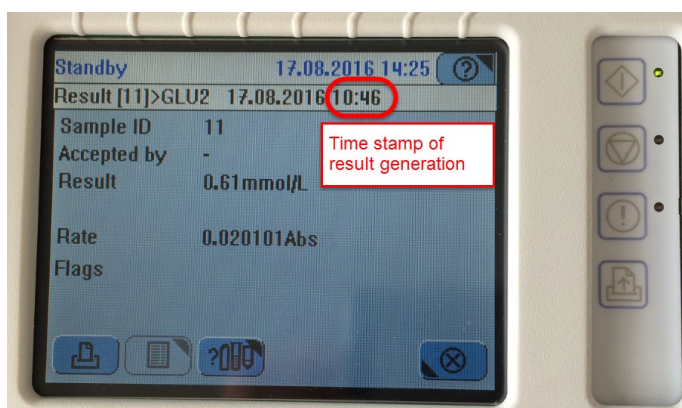
**Fig 4:** Review the time stamp of a sample result.

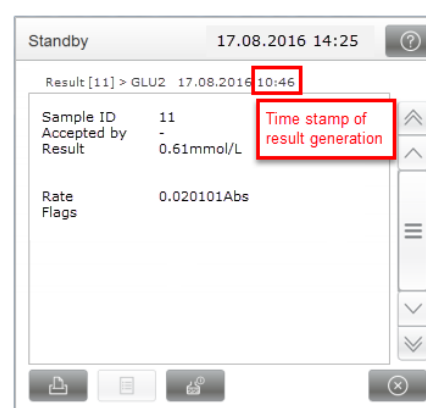
**Fig 4.1:** Review the time stamp of a sample result on an 8.4” display.
