# Field Safety Notice

## SBN-CPS-2017-015

### cobas c 501/502 operator injury on USM cover 3

<b>Product Name / Device Identifier</b>	<b>cobas c 501</b> module (GMMI 04745914001) <b>cobas c 502</b> module (GMMI 05964067001)
<b>Affected Instrument Part GMMI / Part No</b>	USM cover 3 (GMMI 05400937001)
<b>SW Version</b>	Not related to the software version
<b>Type of Action</b>	Field Safety Corrective Action (FSCA)

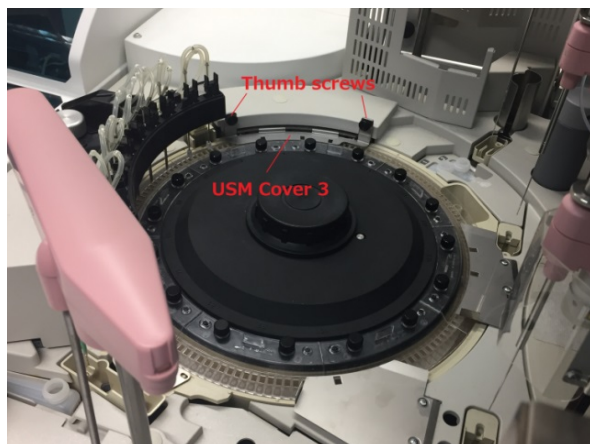
1. The operator was performing monthly maintenance of cleaning the incubation bath and replacing the cuvettes on a **cobas c 502** module.
2. In order to perform Step 1, thumb screws needed to be loosened to remove the USM cover 3, as illustrated in Figure 1.
3. While loosening the left thumb screw, the operator felt a sharp pain in her left thumb and realized that it was bleeding. Her thumb was injured by the 90 degree-edge of the USM Cover 3, which is shown in Figure 2.

Figure 1: Picture of USM Cover 3 and its thumb screws

Customers are advised not to overtighten the thumb screws when replacing the cover after maintenance. When removing the screws for maintenance, **avoid** touching the edge of USM Cover 3.

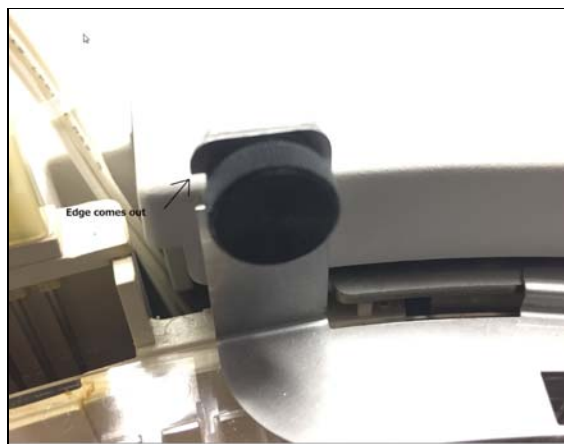
Figure 2: Sharp edge of USM Cover 3

Although the sharp edge of the USM Cover 3 is clearly visible, a medical risk due to an injury cannot be excluded. Since the launch of the product in 2006, only one incident as described above has been reported.

A warning will be added to the respective Operator Manuals, which will be available by December 2017.
