Field Safety Notice

SBN-CPS-2019-009

28-May-2019

Damaged assay cups in two lots of AssayTip/AssayCup Combiracks

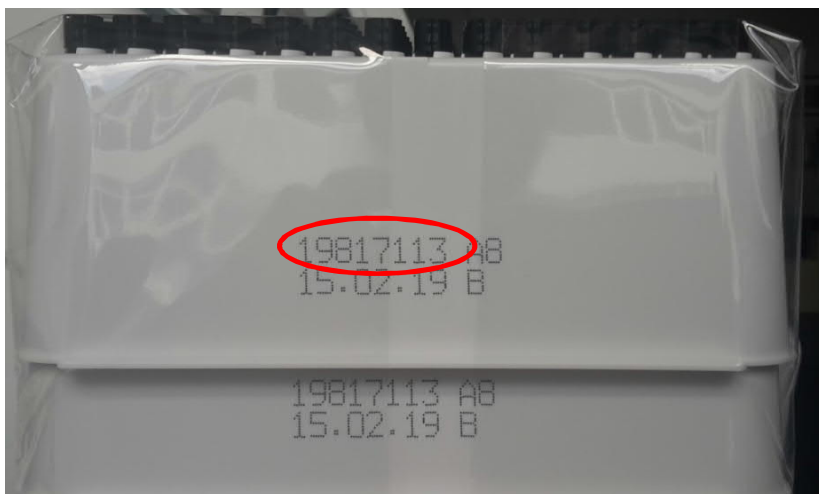
Figure 1: Example of a lot number printed in the AssayTip/AssayCup CombiRack tray

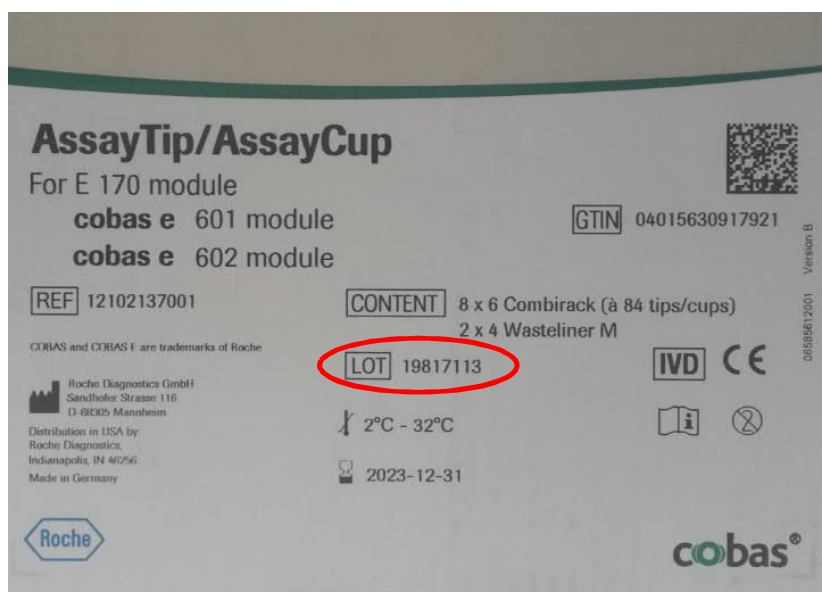
Figure 2: Example of a lot number printed in the AssayTip/AssayCup CombiRack box

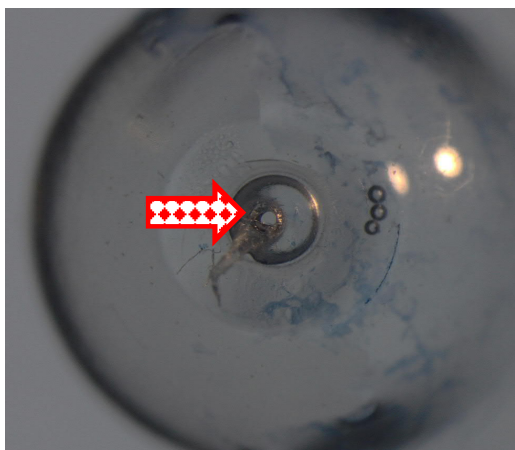
The defect consists of a small hole at the bottom of up to 3% of the total amount of Assay Cups produced in lots 19817113 and 19818113. The affected products represent 0,06 % of the yearly production of this product (GMMI 12102137001).

- Damaged AssayCups are likely to be found in groups in the package (i.e. not a single isolated damaged AssayCup).
- The use of the defective AssayCups from the two affected lots may trigger alarms on the analyzers; however, it is not guaranteed that alarms will be associated with each and every damaged AssayCup.
- Discrepant results without an alarm message and/or flag cannot be excluded.
- Customer may also observe a leaking AssayCup, or AssayCups may fall near the incubator.

Figure 3: Example of a damaged AssayCup with the small hole at the bottom, which can only be seen with magnifying glasses. The small hole is marked by the red arrow. Blue colored water and the three water droplets next to the small hole are the result from previous investigations.

This issue was caused by a partial blockage in two out of 32 cavities used in the production of the AssayCups for a short time. An immediate corrective action was taken in order to avoid recurrence of the issue. No other lots were affected.

- Customers must check if they received AssayTips/Assay cups from one of the lots: 19817113 and 19818113.
- Customers must stop using the affected AssayTip/AssayCup lots.
- AssayTips/AssayCups from the affected lot numbers must be discarded locally and replaced by different lot numbers. Customers are advised to also check the lot numbers of the trays placed in the instruments.
- In case patients' results were released using those two lots, appropriate patient re-testing may be advisable, taking into account patients' medical history and clinical examination.
