# Field Safety Notice

## *SBN-CPS-2019-017*

08-Aug-2019

## AssayTips with abnormal internal structure used on cobas e 801

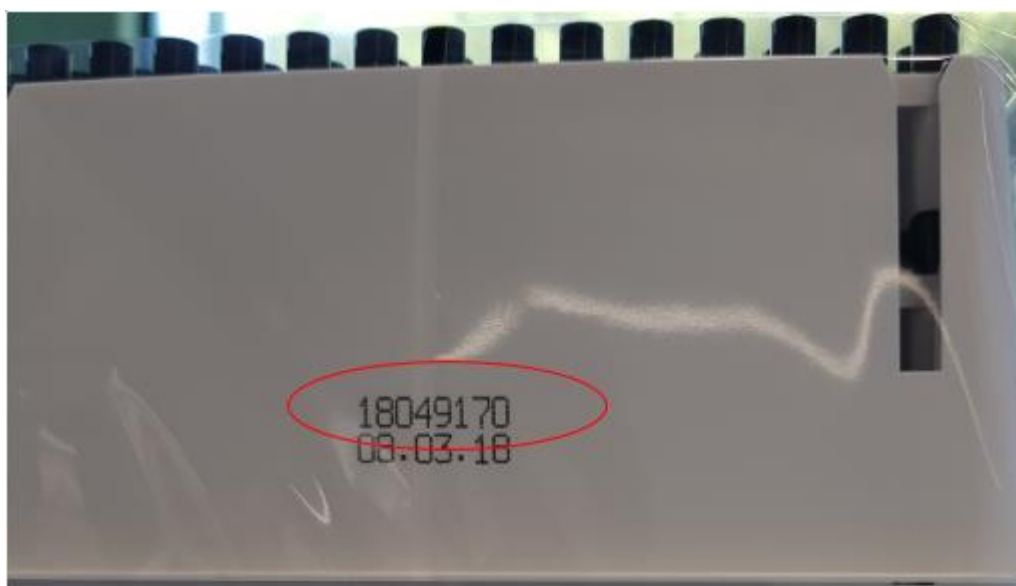
The affected lot numbers can be visually identified on the tray (Figure 1) and on the tray box (Figure 2).

**Figure 1:** Example of a lot number printed on the AssayTip/AssayCup tray

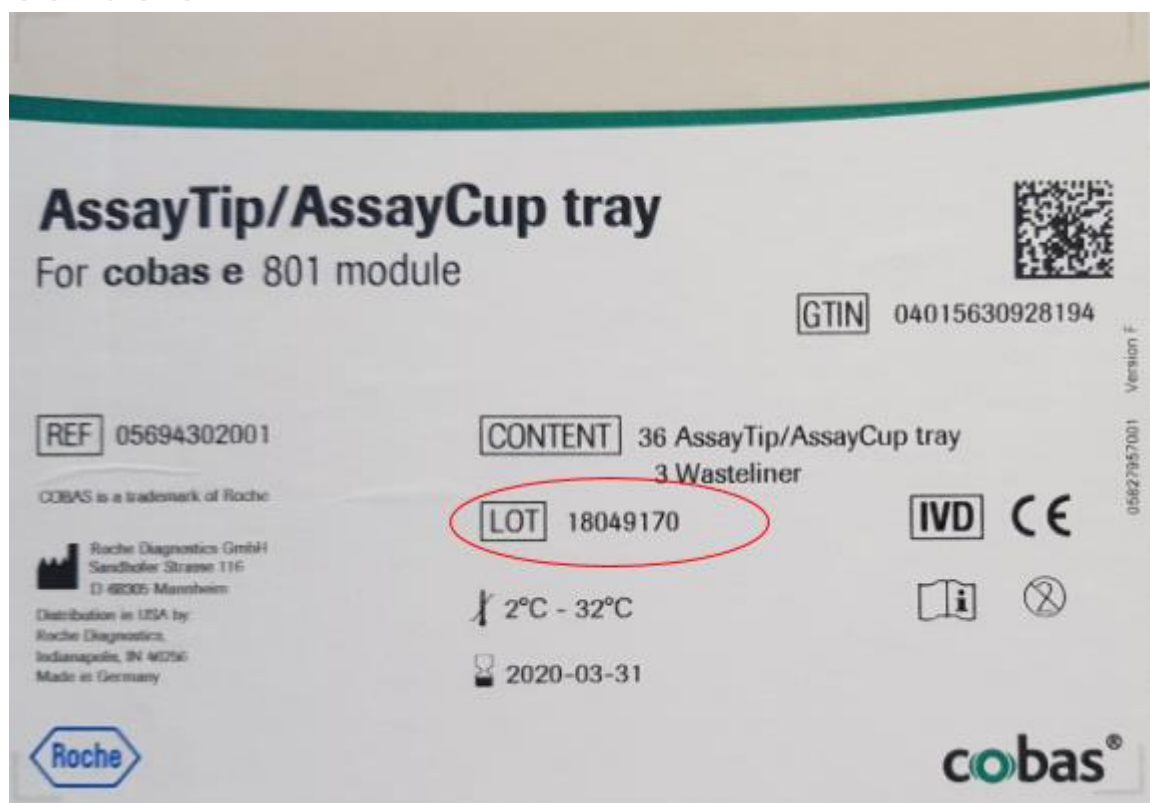
**Figure 2:** Example of a lot number printed on the AssayTip/AssayCup tray box

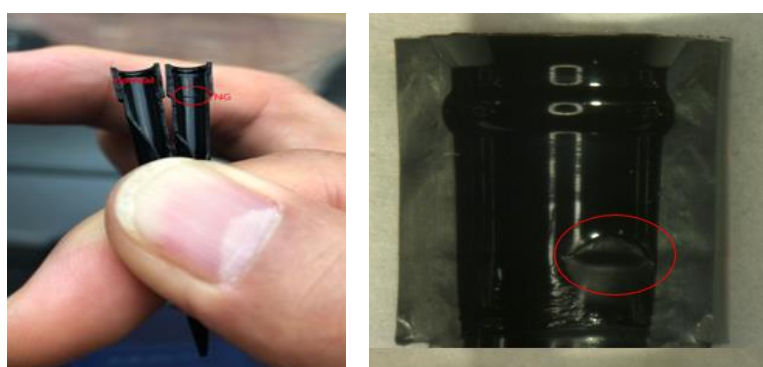
Roche has received a small number of customer complaints regarding defective AssayTips (Figure 3) and after subsequent internal investigations, lots with abnormal internal structure were identified.

- Due to the abnormal internal structure, there might be a not optimal fit of the AssayTip with the sample probe. Thus, insufficient sample volume could be pipetted.
- Discrepant results without alarm message and/or flag cannot be excluded. Typically, low results of several consecutive measurements may occur.
- AssayTips with abnormal internal structure are likely to be found in groups in the tray (i.e. not a single isolated AssayTip with abnormal internal structure). Not all AssayTips from the affected lots are out of specification.

**Figure 3:** Examples of cut AssayTips with abnormal internal structure. The AssayTip includes a burr marked by a red circle.

An error affecting certain cavities of the production molds occurred in part of the production lines at our external supplier. This error led to the production of AssayTips with abnormal internal structure. The supplier has taken immediate corrective action in order to avoid re-occurrence of this issue. Current production is not affected by this error.

- The external supplier has identified the root cause and has immediately taken corrective action to avoid re-occurrence of this issue.
- Roche Diagnostics have stopped distribution of the affected AssayTip/AssayCup tray lots.

- We have identified 2 affected lots, 18656170 and 18661170, that were delivered to your laboratory from Nov 2018 to Jan 2019. Subsequent deliveries to the laboratory are checked to be of unaffected lots.
- The remaining (if any) affected AssayTip/AssayCup tray lots (in storage as well as in instrument) cannot be used and must be discarded immediately.
- In case that discrepant results are suspected during use of the affected lots, appropriate patient re-testing may be advisable, taking into account the patients' medical history and clinical examinations.
