URGENT MEDICAL DEVICE FIELD SAFETY NOTICE

Medfusion® Syringe Pump Model Series 3500 and 4000

Syringe Recognition

Type of Action: Correction (Field Safety Notice)

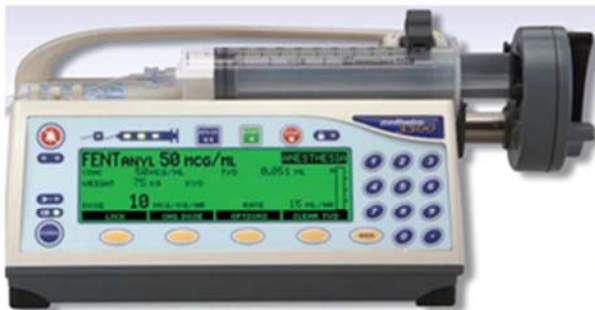
**Medfusion® 3500 Series
Syringe Pump**

Smiths Medical has recently become aware that certain Medfusion® Syringe Pump Models, Series 3500 and 4000, may not be recognizing or may be misidentifying loaded medication syringes. The inability of a pump to recognize a syringe (i.e. the size of the syringe is unknown to the pump) results in an inability to complete pump programming. Misidentification of a syringe may also occur, in which the pump misinterprets the syringe size.

1. Please advise all clinicians overseeing use of Medfusion® Syringe Pump Model Series 3500 and 4000 in your facility to utilize the enclosed Reference Tool to verify the syringe size.
2. If the syringe is not recognized or is read as an incorrect size during any part of the programming or the infusion, remove the pump from service for repair by a trained biomedical technician.
3. If you are a distributor please immediately notify your impacted customers of this Field Safety Notice.
4. Review and complete the attached Response Form and return it to SmithsMedical7612b@stericycle.com within 10 days of receipt of this letter. The form must be returned even if you no longer have any of the potentially affected Medfusion® Syringe Pump Model Series 3500 and 4000 in your possession.
