**IMMULITE® 2000**  
**IMMULITE® 2000 XPi**

## Water and Liquid Waste Bottles Issue

## Reason for Correction

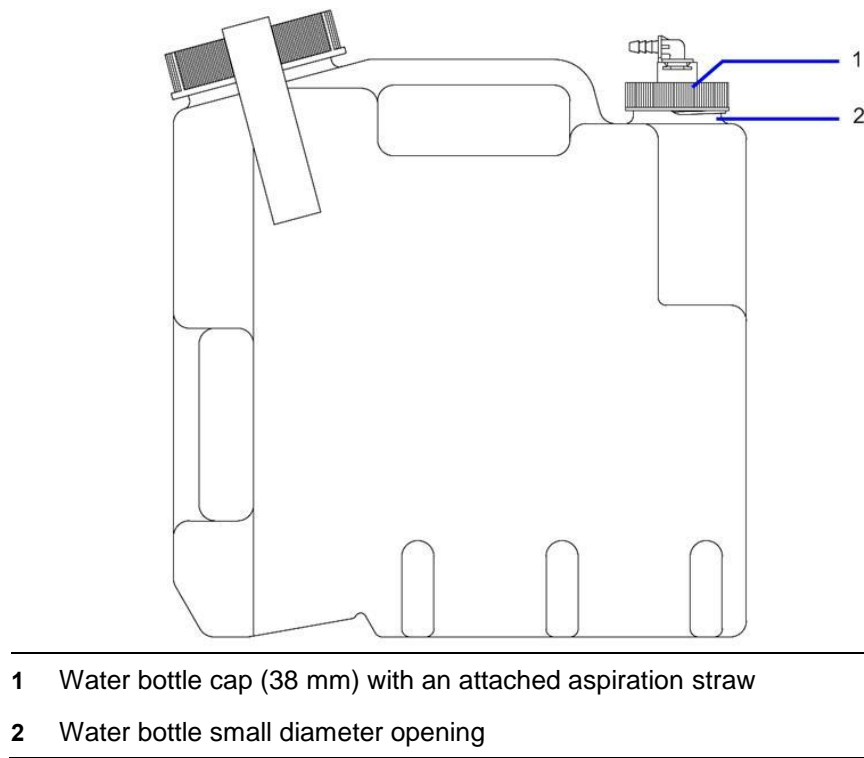
**Figure 1. Water Bottle Assembly**

Siemens has identified that the water and liquid waste bottle assemblies were manufactured with a quality issue. The smaller diameter opening of both bottles is undersized and/or deformed, preventing the cap from closing or fastening securely to the bottle.

1. Install the water bottle onto the instrument.
2. Verify that the 38 mm cap is securely fastened onto the water bottle. This will ensure that the aspiration tubing attached to the cap reaches the bottom of the water bottle. Refer to Figure 1.
3. Fill the water bottle.

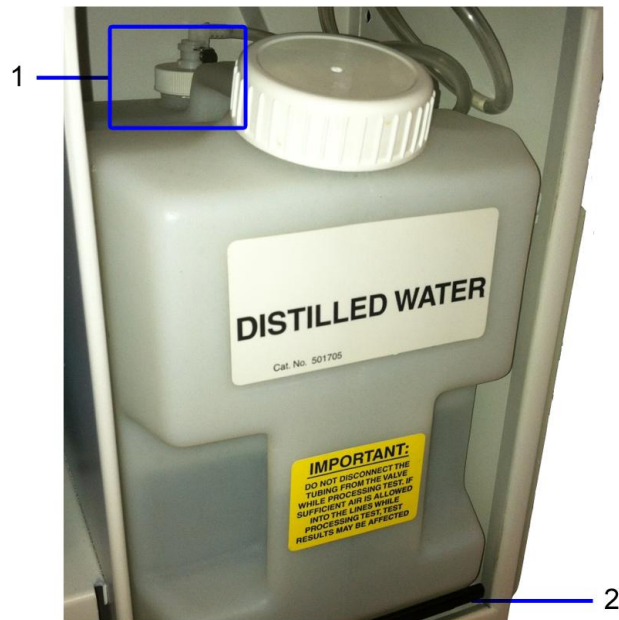
**Figure 2. Securely Fastened 38 mm Water Bottle Cap**

- 
- 1 Water bottle cap (38 mm) securely fastened
  - 2 Water bottle assembly properly seated in compartment
-

4. After refilling is completed and the water bottle placed back onto the instrument, verify that the cap remains securely fastened. Refer to Figure 2.

6. Periodically verify that the 38 mm cap remains securely attached to the water bottle during instrument operation. Refer to Figure 2.
7. If the 38 mm cap is dislodged from the water bottle, perform the following:

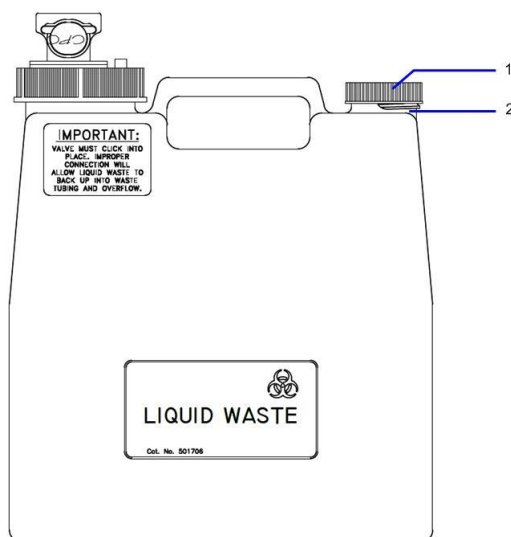
**Figure 4. Liquid Waste Bottle Assembly**

The small opening is used to pour waste from the bottle. If the cap dislodges during transport of a full bottle, care must be taken to avoid spillage.

- 
- 1 Liquid waste bottle cap (38 mm)
  - 2 Liquid waste bottle small diameter opening
-

Ensure when transporting the Liquid Waste Bottle (Figure 4) that you are wearing appropriate Personal Protective Equipment (PPE). There are no other mitigation instructions as a defective liquid waste bottle will not disrupt test processing and there is no potential risk to health as long as you are wearing proper PPE.
