## Urgent Field Safety Notice

CC 17-18.B.OUS

### ADVIA Centaur® XPT

Follow-Up: Mitigation Identified for:  
ADVIA Centaur XPT - T3 Kit Lots Ending in 198 System Error

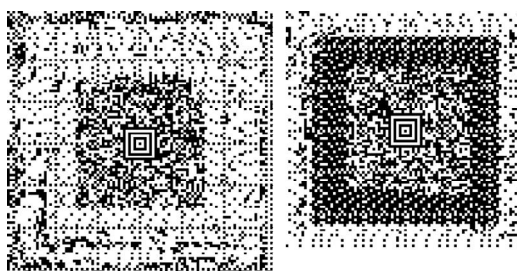
Test Definition, revision 1.8 (for ADVIA Centaur XPT):

Siemens has completed the investigation and determined that the issue is caused by an error in the ADVIA Centaur XPT 2D barcode on the Master Curve Card (MCC) associated with T3 lots listed in Table 1.

- To implement T3 kit lots listed in Table 1 on your ADVIA Centaur XPT system, it is important that you perform the following steps, **in the order specified below**, to avoid an un-recoverable system error:
  1. Scan the corrected T3 Test Definition 2D barcode below onto your ADVIA Centaur XPT system. This will update the T3 Test Definition to revision 1.8.

2. Verify that the T3 Test Definition on your ADVIA Centaur XPT system is revision 1.8 using the following steps on the system workstation:
    - Go to Setup

- Select the Test Definition tab
    - Select T3
    - Verify that the "Test Version" is 1.8
  3. Scan the 2D barcode on the MCC included with the ADVIA Centaur T3 kit lots listed in Table 1. This will successfully install the lot specific parameters required to run kit lots listed in Table 1. By scanning the barcode above in step 1, the system will have the T3 Test Definition revision 1.8. The Test Definition contained in the 2D barcode on the MCC (revision 1.7) will not be installed on the system by the software as it is an older version, thus avoiding the un-recoverable system error.
