Urgent Field Safety Notice

LAI18-04.A.OUS August 2018

Aptio® Automation StreamLAB® Automation

Some modules missing pacemaker warning labels

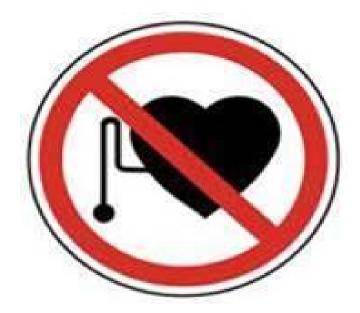
- In the modules listed in Table 1 and 2, the transport mechanism that moves the robot along the axes, generates a magnetic field which may interfere with pacemaker functionality at close distances.
- The pacemaker safety label shown below indicates the potential risk of interference to pacemaker functionality. On some modules, this label may be missing.

Tape this sheet to any module listed in Table 1 or Table 2 that is missing a warning label:

- 1. Personnel fitted with a pacemaker must not be at distances less than 200 mm (7.87 inches) of the modules axes (transport mechanisms) for the modules listed in Table 1 and Table 2 even if the warning label is missing.
- 2. Verify that the modules listed in Table 1 and 2 all have a pacemaker safety label attached either on the cover or inside the cover of the module. If there is no safety label on the module,

please remove the last page of this letter and tape a copy of the safety label to the cover of the module until an official Siemens product label is available.
