**syngo.CT Cardiac Function**  
used in *syngo.via* VA20A, VA30A or VB10A  
**syngo.CT Cardiac Planning**  
used in *syngo.via* VB20A or VB30A

**Safety Advisory Notice SY015/19/S**

### Subject: *syngo.CT Cardiac Function* / Planning – Risk of wrong measurement in the annulus-plane

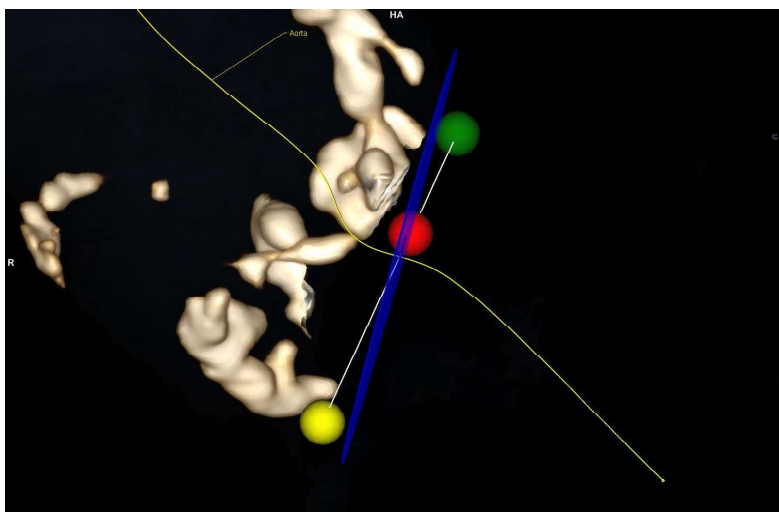
During the automatic procedure a smoothing algorithm subsequently adjusts the shape of the centerline. In unfavorable conditions this smoothing algorithm can result in a slight distortion of the centerline and ultimately in a tilting of the measurement plane compared to the previously defined annulus plane. Any measurements of annular parameters taken under the described conditions might be incorrect due to the tilted measurement plane.

The magnitude of the deviation depends on the initial shape of the individual centerline related to the patient's anatomy. The stronger the initial bend in the centerline, the stronger the correction level of the smoothing operation. Please note that the bending of the centerline may be influenced by potential massive calcifications of the aortic root.

When evaluating the annular dimensions the operator has to ensure that the measurement plane is optimally aligned with the annulus plane. This can be checked in the VRT segment as shown in Fig. 1. For this check, the operator has to move to the annulus plane by pressing the button "Annulus Plane". By activating the vessel diameter measurement tool a blue measurement plane will be displayed and can be compared with the white annulus plane. If they are not aligned, as seen in Fig. 1, any measurements using the cross-sections of the curved planar reformation may not be accurate.

Fig. 1: VRT segment with angular misaligned measurement-plane (blue) and annulus-plane (white) in a worst case situation

**Important:** If the operator recognizes a significant deviation of two planes as shown in Fig. 1, it is absolutely essential to avoid any measurements in the CPR segments using the cross-sections at the annulus plane.

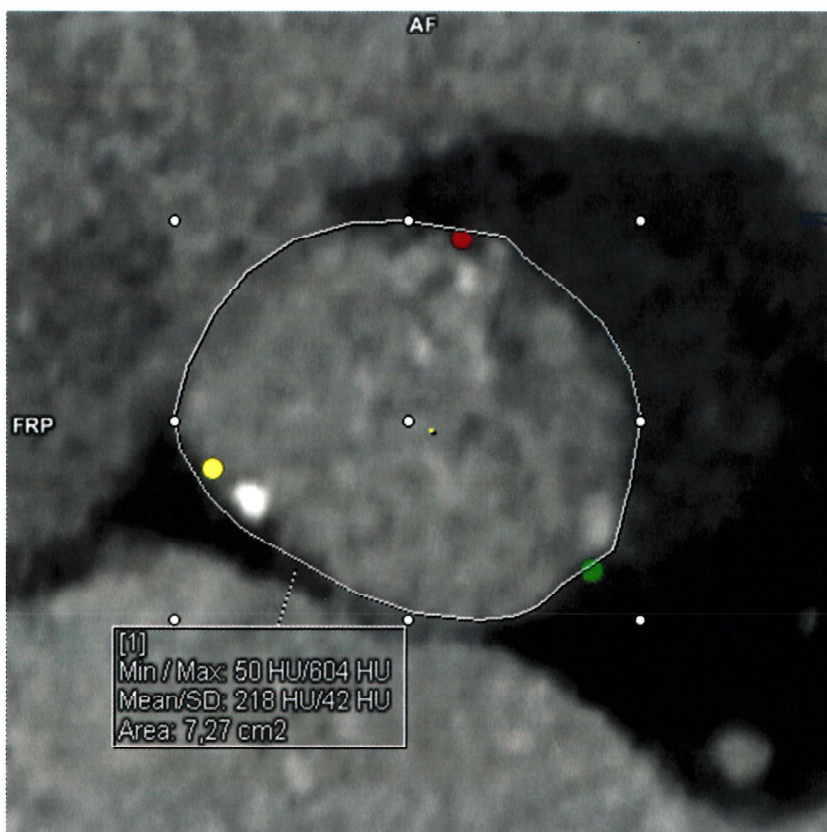
Fig. 2: MPR example for correct manual measurement using the function "ROI Polygonal Measurement"

**Workaround:** As shown in Fig. 2 any annular measurement shall be performed manually in the MPR segment showing the annulus plane instead. The ROI Polygonal and/or Distance Line tools can be used.
