SOMATOM Force
SOMATOM Definition AS
SOMATOM Definition Edge
SOMATOM Definition Flash
SOMATOM Drive
SOMATOM Confidence
SOMATOM Edge Plus
with software *syngo* CT VB10A

Customer Safety Advisory Notice CT035/19/S

Subject: Potential safety related software issues in *syngo* CT VB10A software running on several types of SOMATOM CT scanners – Potential safety related issues solved in *syngo* CT VB20 software

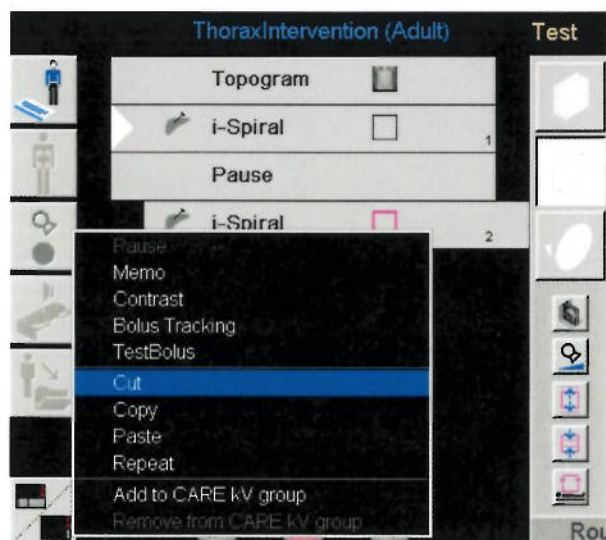
- 4.) The systems may sporadically crash during an interventional workflow using the cut functionality. Details: This issue can happen when the following conditions are fulfilled. An Intervention examination is already started and an i-mode (i-spiral, i-sequence, i-fluoro) is loaded. In this situation the chronicle context menu option <Cut> will lead to a software crash. For details see Fig. 1 below.

Fig. 1: Example of how issue 4 may occur.

- 3.) The series description changes unexpectedly: To avoid this highly sporadic issue, the operator should check the series description for any unexpected changes after the scans have been completed and before the recon jobs are started. It can be changed back manually if the recon has not yet started.
- 4.) Crash during interventional workflow: After the software crash, a system restart is needed. To prevent this happening, the loaded Intervention examination has to be canceled (press <Cancel> button) before a chronicle entry is cut.

These issues will be resolved with the next *syngo* CT VB20 software version. Its release is planned for Q4/2019.

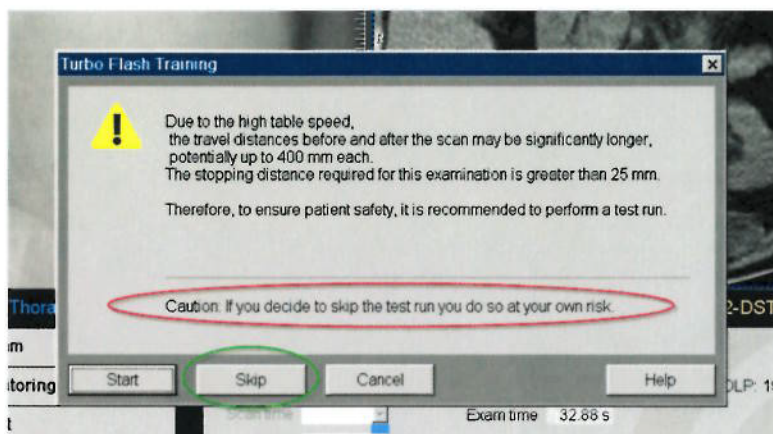
- 2.) For SOMATOM Force users only: When planning a "Turbo Flash" spiral scan, the examination task card may lock up. This can occur if a "Care Contrast" scan contains a pre-monitoring scan, a contrast sequence monitoring scan and a "Turbo Flash" spiral scan with a high pitch (>2.3).
Details: After the pre-monitoring scan, the operator selects a ROI and clicks <Accept>. Due to the high pitch (or the high table speed) of the "Turbo Flash" spiral scan, a table test move is proposed to the operator. After clicking <Start>, the system issues a request to press the <Move> button. When the <Move> button is pressed, nothing happens but the table test move dialog pops up again. The exam task card then locks up, if the <Start> button is pressed a second time.

Fig. 2: Table test dialogue with warning if skipped

- 2.) The examination task card may lock up during a "Turbo Flash" spiral scan. In order to avoid such a lock-up, two solutions exist:
 - a. The pitch can be reduced so that the table test move becomes obsolete and is not proposed to the operator any more. This consequently means the examination is no longer a real "Turbo Flash" spiral scan.

- b. The table test move is not a must and can be skipped. If this workaround is chosen, the operator must be particularly cautious and make sure that there are no obstacles in the way of the table top movement. The high table top speed during such examinations makes it impossible to stop the movement within the usually required 25 mm. The travel distance before and after the scan may be up to 400 mm. The corresponding dialog is shown in Fig. 2 below.
