URGENT - Field Safety Notice

Philips IntelliVue Information Center iX (revision A.XX (where XX is 00 to 02) option LAB, PIIC iX revision B.00 option LAB and PIIC iX revision B.0 Enterprise Server (option LAB is bundled)):

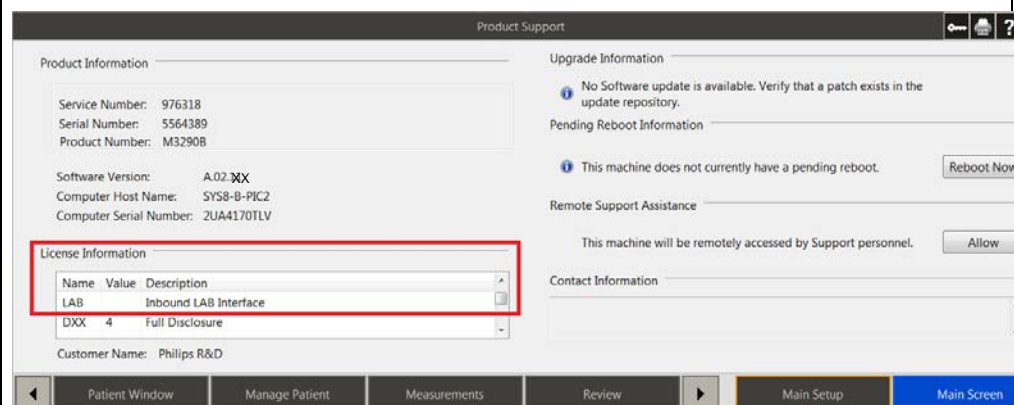
This screen shows the licensed features that have been included. All affected units will show the option LAB active in the License Information.

ACTIONS PLANNED BY PHILIPS	A Philips Healthcare representative will contact customers with affected devices to arrange for the installation of updated PIIC iX software resolving this issue on affected units. Philips will conduct these updates for all affected devices at no charge.
ACTION TO BE TAKEN BY CUSTOMER / USER	<p>To prevent this issue from occurring, customers/users should stop using the LAB feature in the PIIC iX until the software is updated. Remember that the most reliable method of patient monitoring combines close personal surveillance with correct operation of monitoring equipment.</p> <p>Contact your local Philips representative if you have a device impacted by this issue.</p>
FURTHER INFORMATION AND SUPPORT	Should you have any questions or concerns about this Device Correction, please contact your local Philips representative at <key market add contact info here> .

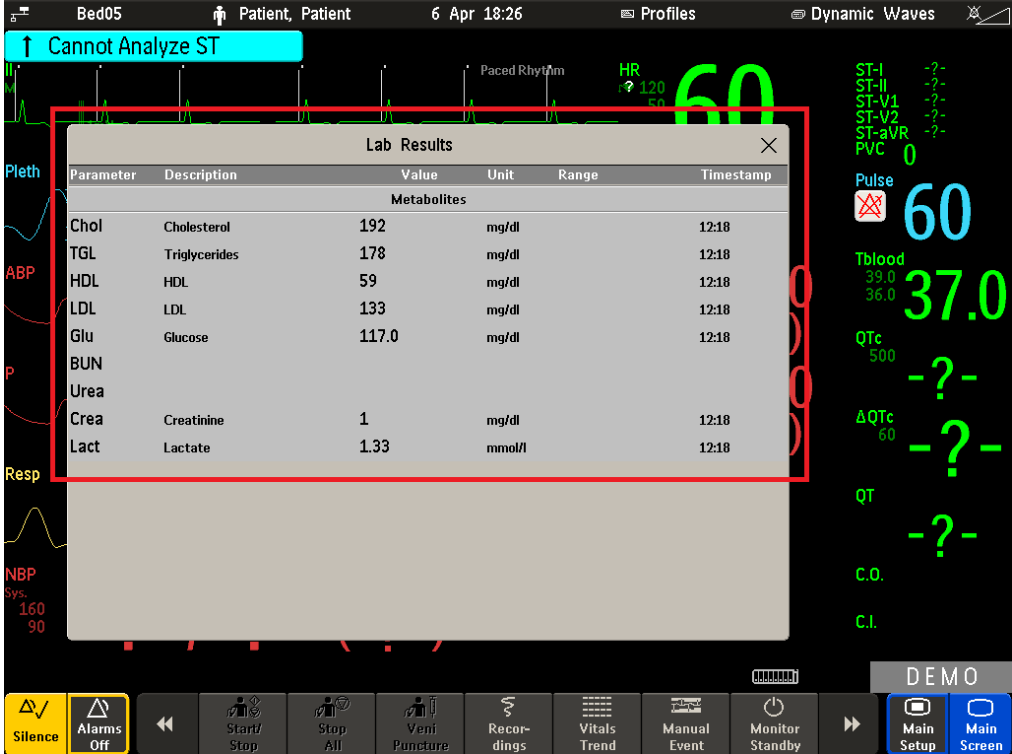
When HL7 lab messages are sent to a PIIC iX system that has been localized for comma delimiters, the lab result is incorrectly displayed on the bedside monitor. An expected delimiter is stripped from the lab value and the number shown is of a higher magnitude than expected. If lab results are incorrect, a clinician may initiate incorrect treatment or delay necessary treatment. This problem only happens when the PIIC iX is configured during set up for regional settings where the delimiter is a comma. The LAB option must be in use, and the workflow utilizes the automatic lab interface displayed at the bedside monitor.

When the LAB option is in use the bedside monitor shows the following screen:
