URGENT - Field Safety Notice

PHILIPS MX 16-slice Computed tomography x-ray system

Software upgrade from v2.0.0.21479 to v2.0.0.21480

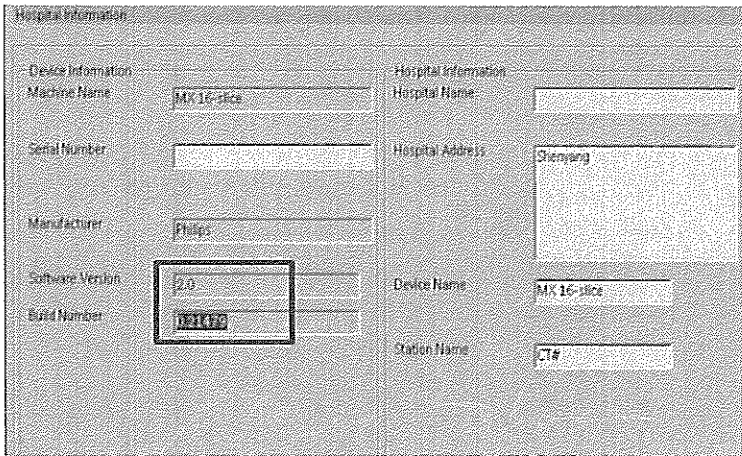
AFFECTED PRODUCTS	Philips MX 16-slice CT Systems with software version v2.0.0.21479
PROBLEM DESCRIPTION	<p>In 2D and Filming function, when image is zoomed and saved as derived DICOM format, the measurement on new created image is incorrect.</p> <p>This issue only occurs on MX16 systems with software version v2.0.0.21479, including MX16 EVO2 systems and MX 16 systems upgraded to MX16 EVO2 using the MX16 iDose4 Upgrade Kit.</p>
HAZARD INVOLVED	Image with incorrect measurement value may be used to guide clinical procedures where measurement is critical. This may lead to misdiagnosis.
HOW TO IDENTIFY AFFECTED PRODUCTS	<p>Identify affected units by the software revision v2.0.0.21479</p> <p>User can identify the existing software version following the steps below:</p> <ol style="list-style-type: none"> 1. Log On the application software with User Name "Config". 2. Click Processing > Service > System Setting> Hospital Information (see Figure 1). 3. Check whether the Software Version is 2.0 and the Build Number is 0.21479 (see Figure 1).

<p>Figure 1: Check the existing software version</p>

ACTION TO BE TAKEN BY CUSTOMER / USER	<p>Do not save images to derived DICOM in 2D. If derived DICOM images are needed, users can save the images in MPR*. Correct measurement result can be obtained on derived DICOM images in MPR.</p> <p>(* MPR is one of the post-processing applications.)</p>

ACTIONS PLANNED BY PHILIPS	<p>Philips will release Field Change Order (FCO) 72800646 to upgrade the software free of charge.</p> <p>A Philips Field Engineer will contact you to schedule this correction.</p>
FURTHER INFORMATION AND SUPPORT	<p>If you need any further information or support concerning this issue, please contact your local Philips representative:</p> <p><Philips representative contact details to be completed by the KM / country></p>
