FSN MA-FCO 72800616

## **URGENT - Field Safety Notice**

### ***PHILIPS MX 16-slice Computed tomography x-ray system***

***Software upgrade from v1.1.4.21425 to v1.1.4.21428 to correct software issues on v1.1.4.21425***

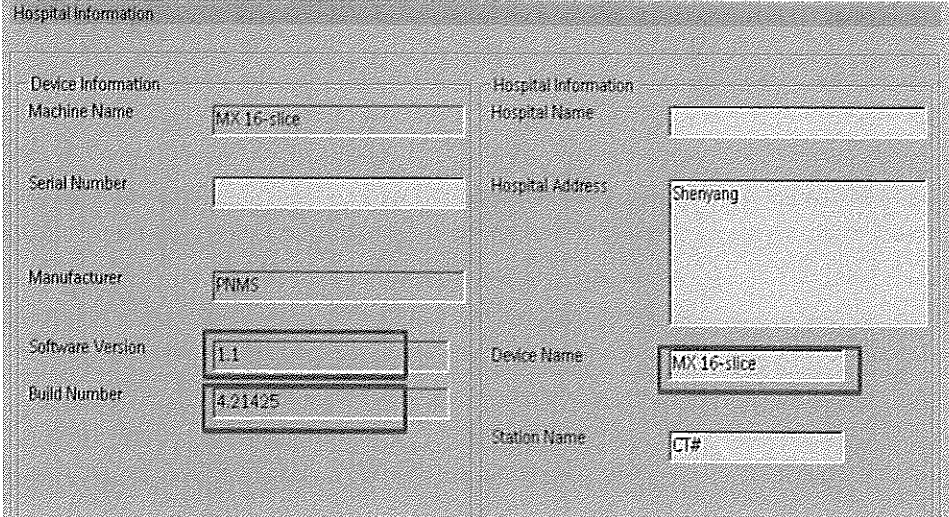
<b>HAZARD INVOLVED</b>	<p>Issue 1) Potential misdiagnosis or incorrect anatomy classification leading to unnecessary treatment/procedure.</p> <p>Issue 2) Scan on wrong body position leading to rescan of patient.</p> <p>Issue 3) Scan on wrong body position leading to rescan of patient.</p> <p>Issue 4) Dental images cannot be post-processed, which may lead to rescan of patient.</p> <p>Issue 5) Potential misdiagnosis due to mixed patient images, which may lead to unnecessary treatment/procedure.</p> <p>Issue 6) Potential rescan of patient when tracker scan is aborted and the following diagnostic scan is not manually started.</p> <p>Issue 7) Invalid SAS scan due to SAS option is not enabled as expected, which may lead to rescan of patient.</p>
<b>HOW TO IDENTIFY AFFECTED PRODUCTS</b>	<p>All the MX-16 Slice Systems with software version 1.1.4.21425 will be affected. User can navigate to "Processing"→ "Service"→ "System Setting" → "Hospital Information" to find the device information. Check whether the Device Name is "MX 16-slice", Software Version is 1.1 and the Build Number is 4.21425 (see Figure 1).</p> <p>Figure 1: Check Device Name and Software Version</p>

<b>ACTIONS PLANNED BY PHILIPS</b>	<p>Philips will release Field Change Order (FCO) 72800616 to upgrade the software free of charge.</p> <p>A Philips Field Engineer will contact you to schedule this correction.</p>
<b>FURTHER INFORMATION AND SUPPORT</b>	<p>If you need any further information or support concerning this issue, please contact your local Philips representative:</p> <p>&lt;Philips representative contact details to be completed by the KM / country&gt;</p>

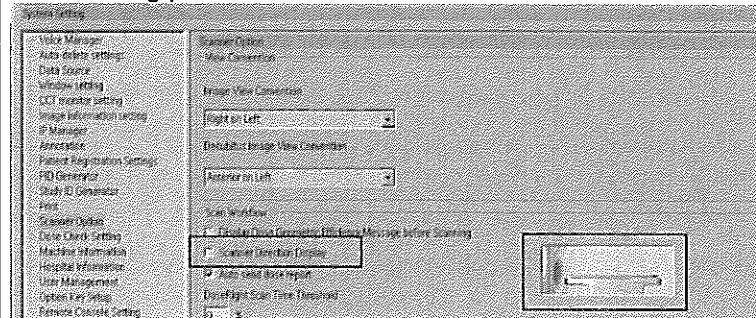
##### Issue 1:

Do not use "Scanner direction display": Open system setting and go to "Scanner Option". If "Scanner Direction Display" option is enabled, cancel (disable) this option.

Note: After the disabling of "Scanner direction display" function, the icon for the patient position in register and protocol select interface will be set as default. This will not affect the scanning process.
