URGENT - Field Safety Notice

Multidiagnost Eleva, MultiDiagnost Eleva with Flat Detector and UroDiagnost Eleva systems.

C-arm may float freely and possibly sag.

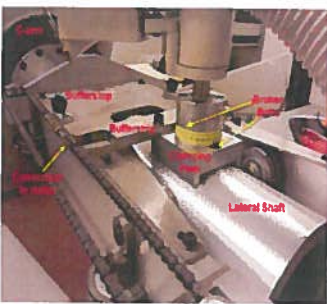
This Field Safety Notice is intended to inform you that recently a problem has been detected related to our MultiDiagnost Eleva system, MultiDiagnost Eleva with Flat Detector and UroDiagnost Eleva systems. Philips has determined that two bolts in the system may break, causing the C-arm to float freely in the lateral direction and possibly sag.

</div> <p>These pictures indicate where the bolts and lateral shaft are located in the scan carrier.</p>														
<p>HAZARD INVOLVED</p>	<p>If a sagging C-arm strikes a patient or operator, it could potentially result in a risk to health. However this risk to health is rarely to occur.</p> <p>To date, there have been no reports of injury associated with this event. There only has been one report of failure noted during a service call.</p>														
<p>HOW TO IDENTIFY AFFECTED PRODUCTS</p>	<p>All units of the systems identified above are affected. Your local Philips organization will help you confirm that all of your affected systems have been identified.</p>														
<p>ACTION TO BE TAKEN BY CUSTOMER / USER</p>	<ul style="list-style-type: none"> • If the C-arm moves in any unexpected manner or fails to move when directed, please contact your local Philips representative immediately. • Ensure that all staff with access to affected systems are informed of the contents of this Field Safety Notice. • Place this letter with your user documentation. 														
<p>ACTIONS PLANNED BY PHILIPS</p>	<p>You will be contacted by our service organization to schedule an appointment to make the necessary repairs.</p>
