## URGENT – Medical Device Correction

### Philips IntelliVue MX40 Patient Wearable Monitor Configuration Setting Disables Generation and Delivery of ECG Alarms to PIIC iX

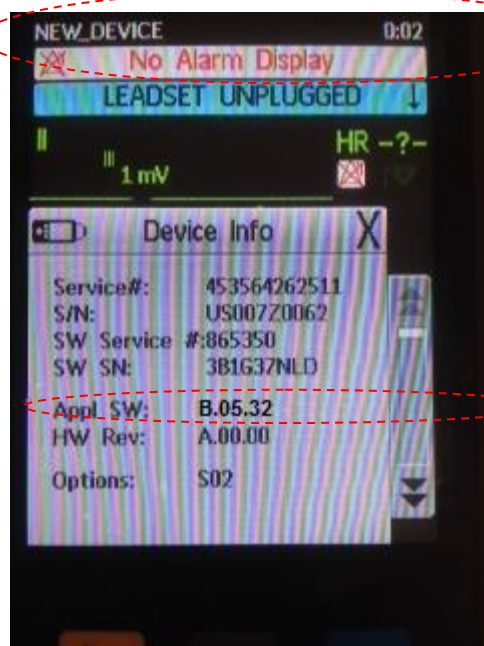
Figure 1: Device Info screen indicating software revision

The MX40 software revision is identified by touching the battery icon in the lower right of the MX40 display which opens the Device Status window. In the Device Status window, touch the Device Info text, to display the application software (Appl SW) version:

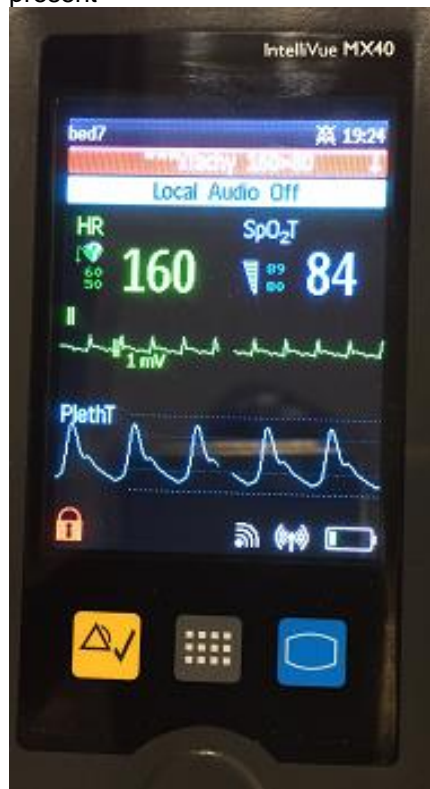
Until your software is upgraded, please make sure that the MX40 Patient Wearable Monitor local configuration setting 'Alarms On' is configured to its factory default. This can be done by following these steps on each MX40 device to enable alarms:

1. Unassign MX40 from the PIIC iX
2. Remove and reinsert batteries
3. Touch MX40 Smart Keys
4. Scroll to select "Op Modes"
5. Touch "Config"
6. Enter password, press "Enter"
7. Scroll to choose Alarms On and touch to toggle to Enabled
8. X to close window
9. Choose "Save" and "Confirm"
10. MX40 reboots and enters Monitor mode
11. Assign MX40 to PIIC iX and verify that "No Alarm Display" banner is no longer present
