URGENT - Field Safety Notice
MobileDiagnost wDR, Rel. 1 and 2

Protective safety cover is missing

FSN MA-FCO 71200159

2016-AUG-30

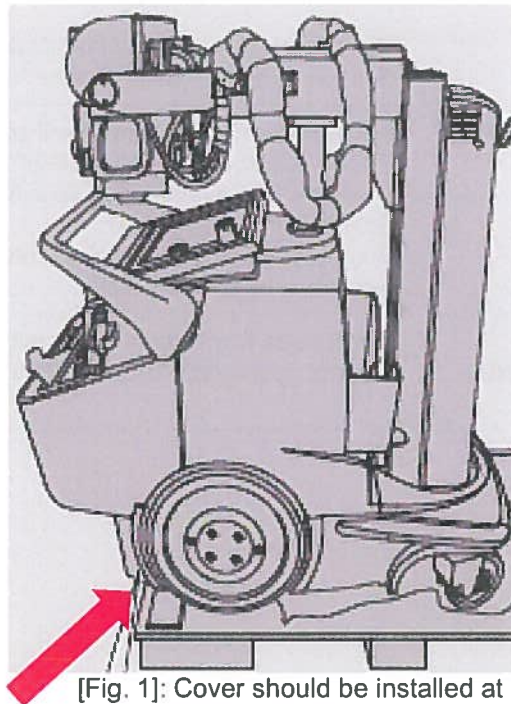
AFFECTED PRODUCTS	MobileDiagnost wDR 1 and 2 in United Kingdom
PROBLEM DESCRIPTION	Protective safety cover is missing (not installed by company)
HAZARD INVOLVED	A hazard evaluation concluded that this cover is a kind of “secondary” measure to protect from potential fire hazards, which by themselves are classified as “extremely unlikely” due to several electrical design measures.
HOW TO IDENTIFY AFFECTED PRODUCTS	Only MobileDiagnost wDR 1 with Serial-No. 13000041 and above in UK and all MobileDiagnost wDR 2 are affected.

[Fig. 1]: Cover should be installed at this edge of the bottom

The customer / user should check if the protective cover is installed at the system.

<p>If the protective cover is <i>not</i> installed, please contact your responsible Philips representative. Please clean the affected area to prevent an issue of dirt or dust inside the system.</p> <p>If the protective cover is installed, the FCO is not necessary for your Mobile-System and the Mobile-System could be used as intended.</p>
ACTIONS PLANNED BY PHILIPS	<p>A Philips Service Engineer will contact you as soon as you contacted your Philips representative in case of missing protective cover. The protective cover is available for installation at your Mobile-System. This step will be done from a Philips Service Engineer.</p> <p>Should you need to communicate with Philips in regards to this program, please reference FCO-71200159.</p>
FURTHER INFORMATION AND SUPPORT	<p>If you need any further information or support concerning this issue, please contact your local Philips representative.</p>

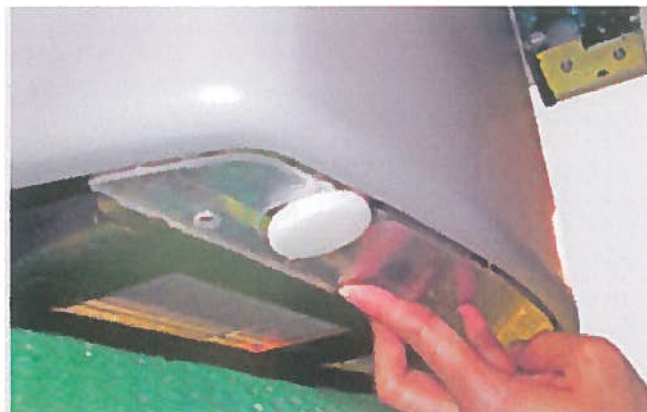
[Fig 2]: If the cover is installed, the Engineer could not grab his fingers behind the front cover of the Mobile-System
