Philips Healthcare

FSN86201774A

URGENT – Medical Device Correction

Philips IntelliVue MX40 WLAN Patient Wearable Monitor may not automatically switch to Monitor Mode with audible alarms when association with central monitoring system is unsuccessful [incomplete]

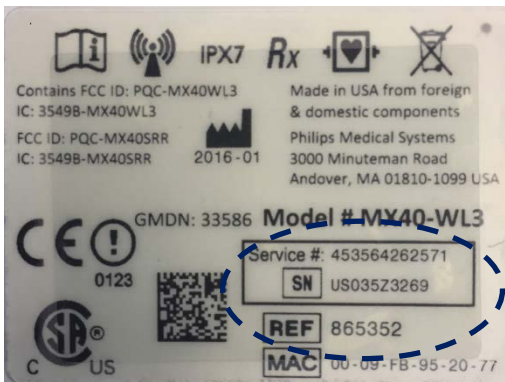
<p>Figure 1: Product number and Exchange part numbers on the product label. Please note, the REF product number may be either 6-numbers or 12-numbers.</p> </div> <div data-bbox="865 846 1317 1396">

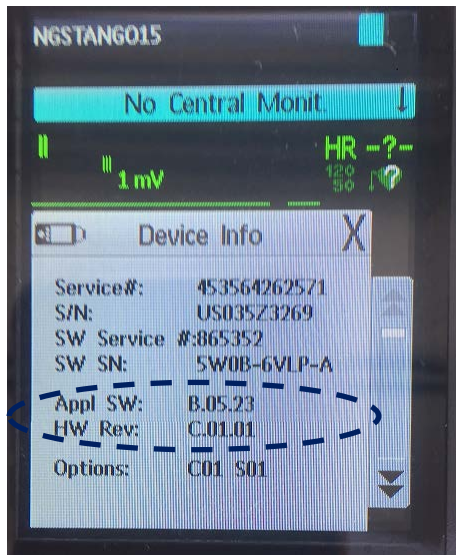
<p>Figure 2: Device Info screen indicating software revision.</p> </div> </div>

ACTIONS PLANNED BY PHILIPS	<ul style="list-style-type: none"> Philips is releasing a software upgrade B.06.18 for affected Philips IntelliVue MX40 Patient Wearable Monitors. <p>A Philips Healthcare representative will contact customers with affected devices to arrange for the installation of the software upgrade.</p>
