Attached is a Field Safety Notice/Field Corrective Order pertaining to the Allura Xper FD20 Biplane due to FCO 72200354. Please note that the serial number of the units affected are stated below:

URGENT - Field Safety Notice

Allura Xper systems

7th or 8th monitor on the Monitor Ceiling Suspension may disengage

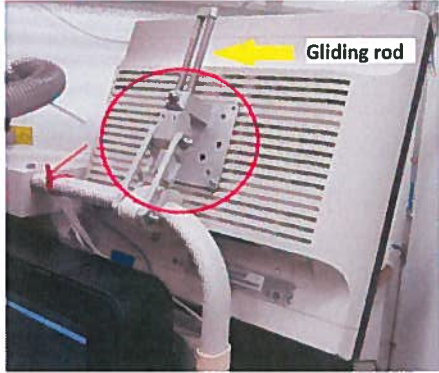
<p>PROBLEM DESCRIPTION</p>	<p>Extra monitors, so called 7th or 8th monitor, mounted on the Monitor Ceiling Suspension (MCS), might disengage from the MCS and fall down. The two small set screws securing the two gliding rods into an aluminum block of the support arm can come loose because of vibrations and forces exerted on them.</p> <p>If the set screws have come loose gravity can keep the rods in position. However, if a force is exerted on the monitor pushing it forward, the monitor can topple forward. Once the monitor has toppled over it is only attached with its wires. If the monitor breaks loose of its wires it will drop on the floor.</p> <div style="display: flex; justify-content: space-around;">

</div>
<p>HAZARD INVOLVED</p>	<p>If the above described problem occurs, it may lead to harm to patient, user, bystander or service engineer, that may necessitate medical intervention.</p>

</div> <ul style="list-style-type: none"> • Position an MCS with a 7th or 8th monitor only before or after an examination. • Avoid positioning the MCS above a patient/sterile field during the examination. • Users must ensure that all staff with access to the affected system are informed of the contents of this Field Safety Notice. • The customer is requested to place this field safety notice with the documentation of the system until this correction has been implemented.
<p>ACTIONS PLANNED BY PHILIPS</p>	<ul style="list-style-type: none"> • All possibly affected products in the field will be corrected free of charge. • A Philips representative will secure the set screws in the affected systems. This will effectively make it impossible for the set screws to loosen under the prevailing conditions. • You will be contacted by our local Philips representative to schedule an appointment to make the necessary corrective action. • This action will start effective December 2017.

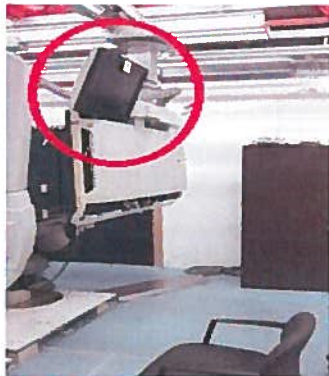
<p>ACTION TO BE TAKEN BY CUSTOMER / USER</p>	<ul style="list-style-type: none"> • Verify if the facility has a 7th or 8th monitor attached to the Monitor Ceiling Suspensions (MCS) <div style="text-align: center;">
