## URGENT - Field Safety Notice

### Medical Device Correction

Ingenuity Flex, Ingenuity CT, Ingenuity Core, Ingenuity Core<sup>128</sup>, Brilliance iCT, Brilliance iCT SP, Brilliance Big Bore Oncology, Brilliance Big Bore Radiology, Brilliance 16, Brilliance 40, Brilliance 64, IQon, Brilliance 6, Brilliance 10

#### Couch Horizontal Motion Controller

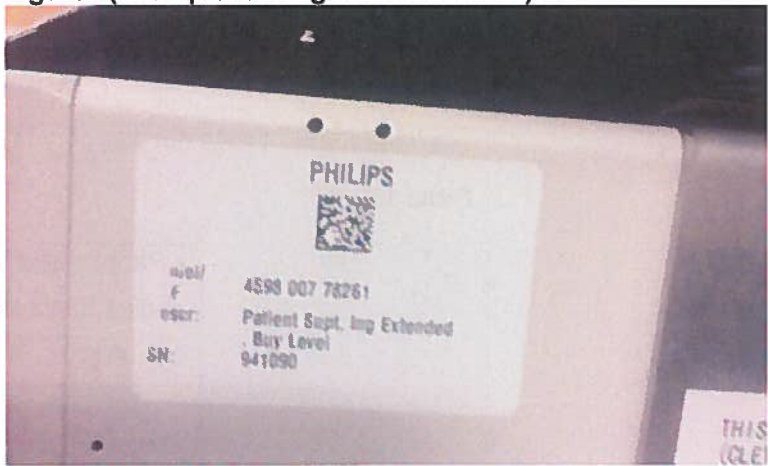
<b>HOW TO IDENTIFY AFFECTED PRODUCTS</b>	<p>There are two sets of serial number ranges that may be impacted. Serial numbers can be either five digit or six digit numbers. The patient support (couch) serial number can be found on a label located on the front closest to the gantry of the patient support (couch) cover. Refer to Figure 1 and Figure 2 for examples of serial numbers. Refer to Table 1 and Table 2 for list of affected patient support (couch).</p> <p><b>Figure1 (Example: six digit serial number):</b></p>
