## URGENT - Field Safety Notice

### Medical Device: MultiDiagnost-Eleva

#### Tilt actuator base unit

FSN: 2017-IGTBST-031  
DocID: DHF308925

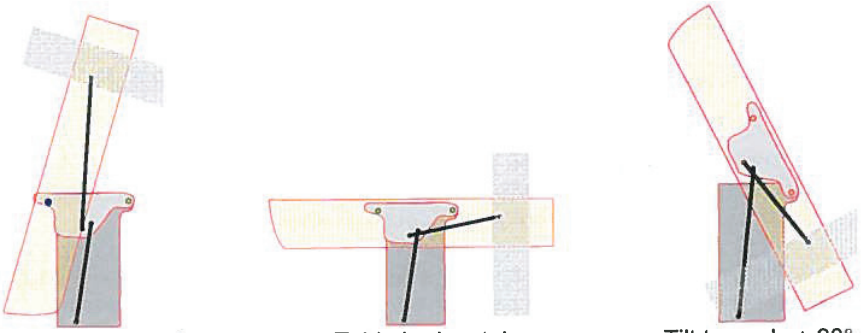
Philips has been reported instances in which the table of the Multidiagnost-Eleva (MD-Eleva) suddenly started to rotate from 0 to 90 degree (table arm down) with high speed. The cause of this unexpected rotation movement is related to an issue with the fixation of the upper and lower tilt actuator.

</div> <p style="text-align: center;">Tilt towards - 90°      Table horizontal      Tilt towards + 90°</p>                                                                                                                                                               |                     |                     |                     |        |             |        |                                        |        |                                        |        |                     |        |                                        |        |                                        |        |
| <b>HAZARD INVOLVED</b> | <p>If the fixation of the actuator breaks off and if the point of gravity of the table is beyond its rotation point, the table starts to rotate uncontrolled to its + / - 90 degree end point, which potentially could lead to the patient falling off the table.</p> <p>During procedures, the system is remotely operated from the control room. In case of an uncontrolled rotation, there is a risk of injury for the patient, user or bystander standing in the vicinity of the system (e.g. the tube may hit the legs of that person). This might lead to harm that necessitates medical intervention for the person involved.</p> | | | | | | | | | | | | | | | | |

| <b>ACTIONS PLANNED BY PHILIPS</b> | <p>All possibly affected products in the field will be corrected by means of a field change order free of charge.</p> <p>A Philips representative will replace affected material on the upper and lower tilt actuator in the affected systems.</p> <p>You will be contacted by our local Philips representative to schedule this corrective action.</p> <p>This action will start effective April 2018.</p> |
