FSN781 00490

URGENT - Field Safety Notice Medical Device Correction

Ingenia Elition S, Ingenia Elition X

Unintended table movement after pressing 'stop-button'

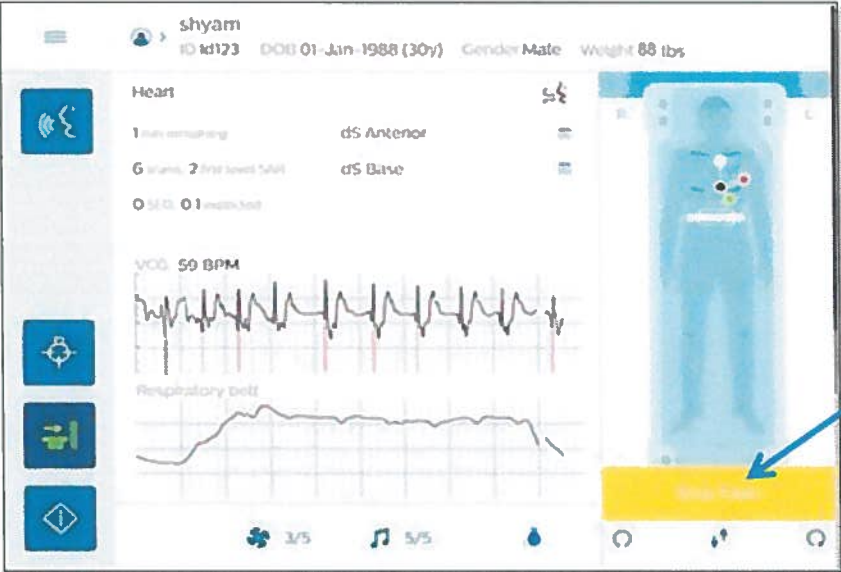
<p>AFFECTED PRODUCTS</p>	<p>Ingenia Elition S (781357), Ingenia Elition X (781358) MR systems</p>
<p>PROBLEM DESCRIPTION</p>	<p>Philips has become aware of a potential hazardous situation with the VitalScreen 'Stop Table' software button on the Affected Products (the yellow button on the right bottom corner as shown with the arrow below).</p> <p>During automatic tabletop movement, pressing and holding the 'Stop Table' button may lead to an unexpected restart of the table movement.</p>

<p>The issue does not occur when the Emergency Table Stop button or the tumble switch is used.</p> <p>Only a combination of the following factors may lead to unexpected table movement:</p> <ol style="list-style-type: none"> 1. User presses and holds the VitalScreen TTS button to initiate automatic tabletop movement (without the use of the tumble switch) and patient is moved into the bore. 2. Patient is taken (partly) out of the bore (example use cases: to inspect the patient or administer contrast) 3. To move the patient out, the VitalScreen TTS button is used again to initiate the second automatic tabletop movement 4. The user wants to stop the table movement 5. The user presses the VitalScreen 'Stop Table' button to stop the table movement. <p>The issue does not occur when the travel-to-scanplane (TTS) button on the VitalScreen is used for the first time during an examination (bullet 1 in the preceding list).</p> <p>The issue was found during an internal assessment at a Philips Test facility, and no person was injured. The issue is not reported by customers.</p> <p>In addition the FCO solves following issues:</p> <ul style="list-style-type: none"> - Software issues reported via customer feedback cases or internally reported issues. - The IfU and Technical Documentation (TD) were updated, amongst others, to be compliant with IEC60601-1-2 4th Edition (EMC).

<p>HAZARD INVOLVED</p>	<p>Mechanical entrapment of the patient between the tabletop and the system cover.</p>

HOW TO IDENTIFY AFFECTED PRODUCTS	Ingenia Elition S (781357) and Ingenia Elition X (781358) MR systems, with software R5.5.0.0
ACTION TO BE TAKEN BY CUSTOMER / USER	<p>The user must follow the Instructions for Use to verify that no part of the patient's body, hair, clothing, cables or infusion lines can get trapped or injured by any part of the equipment. Additionally, the VitalScreen shows positioning guidance regarding arm supports and padding.</p> <p>The user should avoid the use of the yellow 'Stop Table' button on the VitalScreen. The user must always use the tumble switch or physical 'Emergency Table Stop' button for cases which require the table movement to stop.</p>
ACTIONS PLANNED BY PHILIPS	<p>Via FCO78100490 Service Pack 1 for R5.5.0 will be rolled out to the affected systems. With this Service Pack the 'Stop Table' software button on the VitalScreen will be removed.</p> <p>The additional items mentioned in the problem description are implemented.</p>
