FSN781 00484

December 2018

URGENT - Field Safety Notice Medical Device Correction

Additional fixation (grip) of the ceiling speakers of the MR system

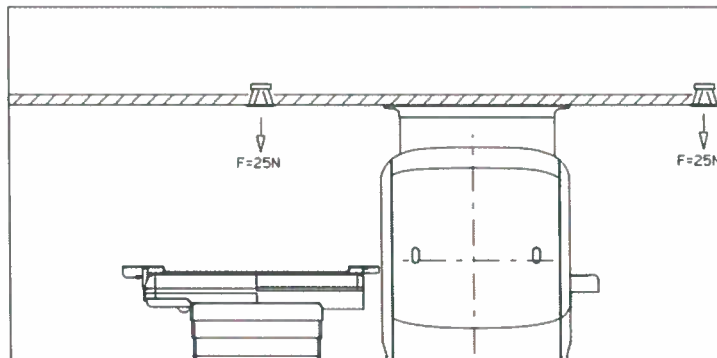
AFFECTED PRODUCTS	Intera, Omniva, Enterprise, Achieva, Achieva XR, Achieva Conversion, Panorama HFO, Ingenia, SmartPath to dStream, Multiva, Prodiva, MR-OR, MR-RT, MR-Linac, MR-Marlin systems
PROBLEM DESCRIPTION	<p>Philips MR systems are standard equipped with two ceiling speakers, positioned in the front and/or rear of the MR system. These speakers enable communication between the operator in the examination room and the patient and offer stereo music or ambient experience audio. These speakers are in most cases fixated in the suspended ceiling of the MR examination room according to the Philips service instructions. The Philips Planning Reference Data (PRD) prescribes the suspended ceiling must be strong enough to hold 25 N speakers.</p> <p>However in very rare cases, due to external influences (hospital facility maintenance, water leakage, degradation of speaker fixation) during the lifetime of the MR system, the ceiling speaker(s) could fall from their position and be pulled to the MR system by the magnetic field.</p>

HAZARD INVOLVED	<p>In case the ceiling speaker or ceiling tile with speaker drops down, it will get pulled to the MR system by the magnetic field. This potentially can result in:</p> <ul style="list-style-type: none"> - serious injury to a patient, operator or other persons in the examination room - damage to the MR system, e.g. covers <p>The severity of such event depends on where, how and if the ceiling speaker or tile hits a person or system.</p>
HOW TO IDENTIFY AFFECTED PRODUCTS	<p>All MR systems listed above have been delivered with two Philips speakers. The customer can visually check if these ceiling speakers are mounted in the ceiling.</p> <p>Note: At some customers, ceiling speakers are mounted to the wall with a wall mounting box, which does not present a similar risk. Therefore, wall-mounted speakers are out of scope for this notification.</p>

- Following checks/actions by the customer are recommended:
- Check if the speakers are mounted in the ceiling.
 - Visually check for signs of fixation degradation: e.g. water leakage, color changes of ceiling tiles, poorly positioned tiles.
 - In case of suspected insufficient fixation, do not correct the fixation yourself, but immediately contact your local Service/Philips representative.
