Field Safety Notice

FSN for 2017-IGTBST-029

URGENT – Field Safety Notice

Bent pedal of footswitch might cause interruption of live Fluoroscopy imaging or exposure.

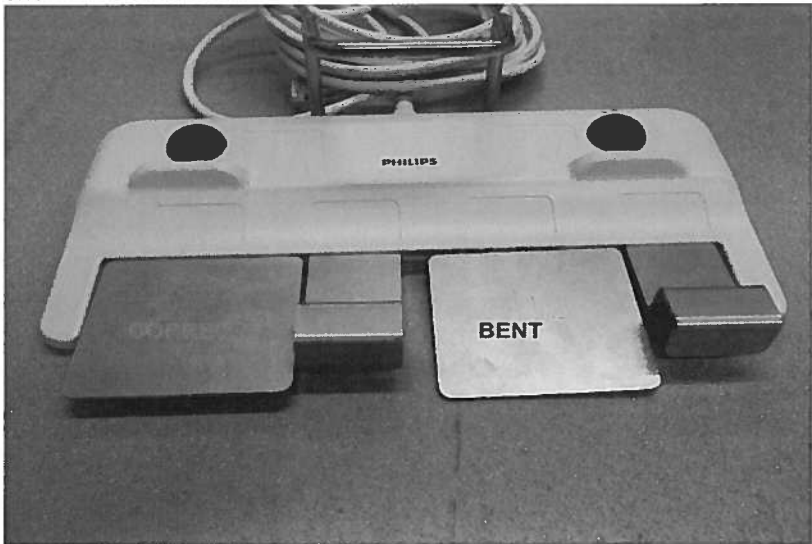
Philips noticed that due to a bent pedal of the footswitch, loss of image functionality is possible (intermittent or continuous inability of making live fluoroscopy images or exposures).

The pedal may get bent when the footswitch is frequently used on an anti-fatigue mat or on a not flat surface or in the pedestal.

<p><i>Left pedal is correct. Third pedal from left is bent. Distance to floor should be approx. 12mm (0,47inches).</i></p> <ul style="list-style-type: none"> Do not use the footswitch on an anti-fatigue mat or in the pedestal. Please ensure that all staff with access to the affected systems are informed of the content of this Field Safety Notice. Include this Field Safety Notice together with the documentation of the system until the system has been corrected by Philips.
ACTIONS PLANNED BY PHILIPS	<p>The problem will be resolved by an update of the mechanical hardware of the Footswitch that will prevent that the pedals of the footswitch becoming bent.</p> <p>This mechanical hardware is available by February 2019.</p> <p>You will be notified by your local Philips representative to schedule a date for installation of this mechanical hardware update.</p>

ACTION TO BE TAKEN BY CUSTOMER / USER	<ul style="list-style-type: none"> Before the start of a procedure, the user must check the footswitch for possible bent pedals. See images below on how to identify a bent pedal. If bent pedals are found the procedure should not continue and Local Service should be contacted.
