URGENT - Field Safety Notice

Ingenuity CT, IQon Spectral CT, iCT, Brilliance 64 CT, Ingenuity TF, Vereos

Step and Shoot Incorrect Image Phase Labeling

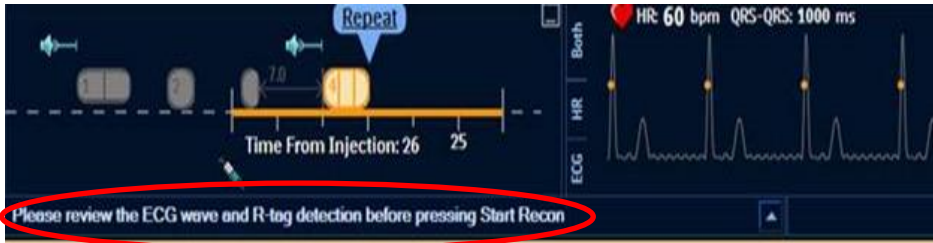
HOW TO IDENTIFY AFFECTED PRODUCTS	<p>Determine whether you have a potentially affected system, then determine your AFFECTED PRODUCTS software version.</p> <p>To identify the software version of your product: Click the "Help" button Select "About" and the software version is then displayed Software versions 4.x, 3.x, and 2.x are potentially affected</p>
ACTION TO BE TAKEN BY CUSTOMER / USER	<ol style="list-style-type: none"> When performing a Step and Shoot acquisition with phase tolerance selected, images may be reconstructed identically (a single phase), but are labeled as different phases. This occurs when "Start Final Recon" is selected prior to display of the ECG wave at the top of the acquisition window. <ul style="list-style-type: none"> Reconstructed phases display as identical in online reconstruction, but reconstruct correctly during offline reconstruction. This occurs when the user clicks 'Start Final Recon' prior to the Console/Host receiving the ECG wave.

<p><i>4.x Graphical User Interface example</i></p> <ul style="list-style-type: none"> How to avoid in 4.x: Wait until the ECG strip is at the top of the acquisition window to starting the reconstruction.

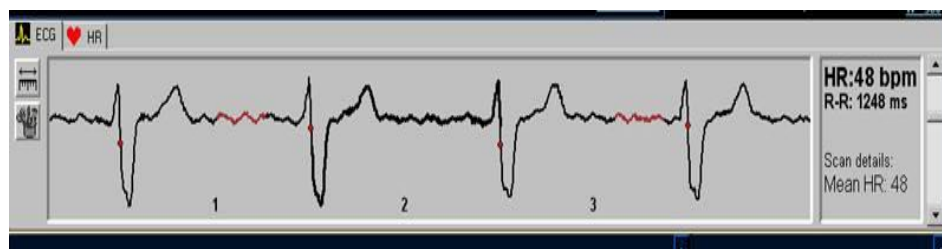
3.x Graphical User Interface example

- How to avoid in 3.x: Wait until the ECG strip is visible at the bottom of the acquisition window to starting the reconstruction.

This issue affects all systems listed above (with the exception of Vereos) with 4.x software and all iCT systems with 3.x software. Images can be reconstructed with phase tolerance by performing an offline reconstruction of the raw data. No patient rescan is required.

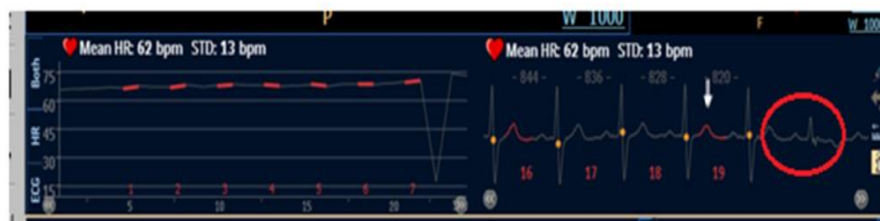
- This can occur with version 4.x software

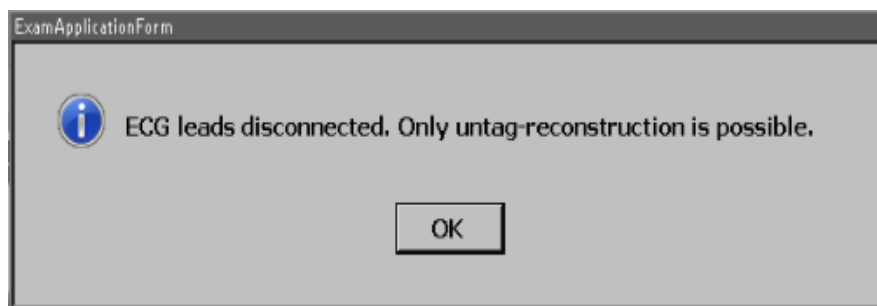
- Should this occur, the user will receive the following console message:

- Images will be incorrectly labeled as if phase tolerance has been applied, however, the images will be reconstructed without phase tolerance.
- How to avoid: Ensure that the leads are securely attached to the patient prior to starting the acquisition and the length of table travel allows the leads to remain securely attached through acquisition completion. In the event of an application crash, there is no way to avoid the issue.
- When this issue occurs, images may still be used but are not labeled with the correct ECG phase. If images with phase tolerance are needed, a rescan may be required.

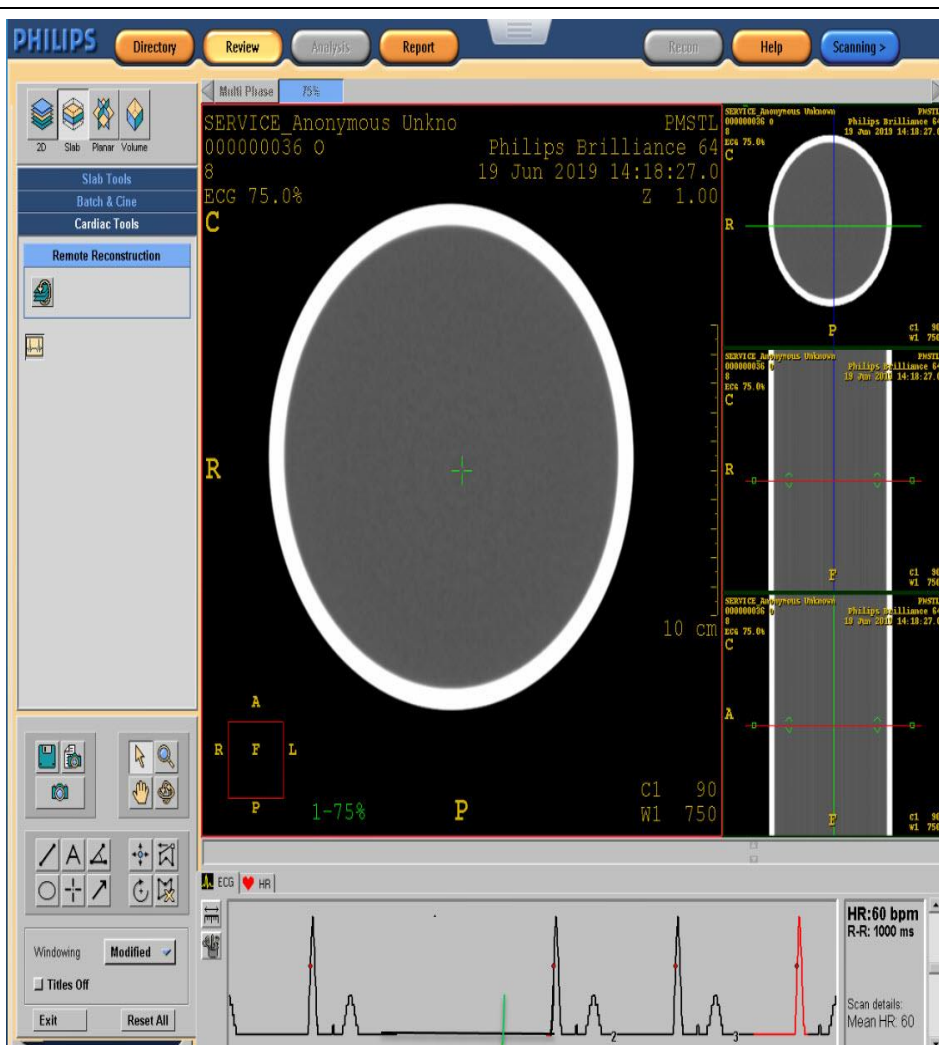
3.x/2.x Graphical User Interface example
