FSN79500527

URGENT – Field Safety Notice

Philips S7-3t & S8-3t Transesophageal (TEE) Transducers Temperature Display Issue

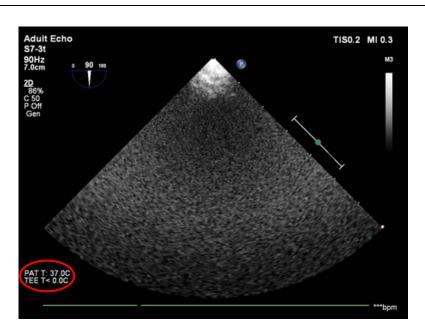
For EPIQ, Affiniti, & iE33 systems			
	 Connect the transducer to the system and ensure that it is secure and locked. If the preset is not already selected by default, select it as follows: S7-3t - Adult Echo, or S8-3t - Pediatric. Find the transducer temperature (TEE T) that appears in the lower left corner of the display. If the transducer temperature on the display shows TEE T <37.0C (<98.5F), then the transducer was properly programmed, and no actions are required. If the transducer temperature on the display shows TEE T <0.0C (<32.0F), then the transducer was not properly programmed (see image below), discontinue using the transducer and contact your local Philips representative. If the transducer temperature (TEE T) does not appear in the lower left corner of the display, follow the instructions below to enable it: 			
	EPIQ & Affiniti			
	 Swipe to the second touch screen Touch Temp Display to display the temperature display

iE33			
	 Display the Preset/Transducer touch screen by touching Preset/Transducer Touch Temp Display to display the temperature display 			
	. 33311 1 1111 Propinty to diopidy the temperature diopidy

If you have an EPIQ, Affiniti or iE33 system, verify that all your S7-3t and S8-3t TEE transducers are programmed properly by connecting them to the system, checking the transducer temperature (TEE T) on the display, and following the instructions provided on this letter.

If you determine that your transducer is not properly programmed, discontinue using the transducer immediately and contact your local Philips representative to schedule an appointment with a field service engineer.
