URGENT – Medical Device Correction Field Safety Notice

Philips V60 Ventilators User Interface RP-Kits May Be Impacted by Unresponsive Touchscreen

MEDICAL DEVICE FIELD SAFETY NOTICE RESPONSE
Philips V60 Ventilator User Interface RP-Kits May Be Impacted by Unresponsive Touchscreen

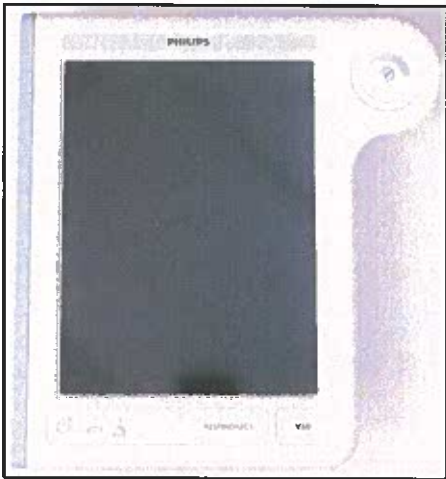
<p>Figure 1: Front View UI RP-Kit</p> </div> <div style="text-align: center;">

HOW TO IDENTIFY AFFECTED PRODUCTS	<p>1) The serial number of the User Interface RP-Kit is located on the external surface of the User Interface Touchscreen RP-Kit. See Figures 1, 2, and 3 below.</p> <div style="display: flex; justify-content: space-around; align-items: flex-start;"> <div style="text-align: center;">

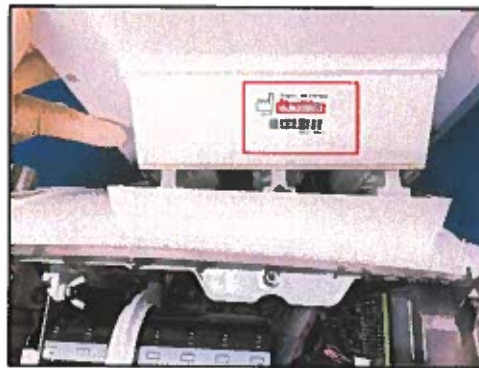
Figure 4: Installed UI Assembly Serial Number

- 2) If the User Interface Assembly RP-Kit indicated in the **AFFECTED PRODUCTS** section above was installed on a V60 ventilator at your facility, review your maintenance records to determine the serial number of the ventilator that used the kit.
- 3) If from review of your V60 maintenance records it cannot be determined which V60 has the affected User Interface Assembly RP Kit listed in the **AFFECTED PRODUCTS** section above, the site biomedical engineer or authorized service personnel must check each V60 ventilator on-site to locate the affected User Interface serial number. (**Figures 4 through 10** are pictorials of how to identify the User Interface Assembly serial number when installed on a ventilator.)

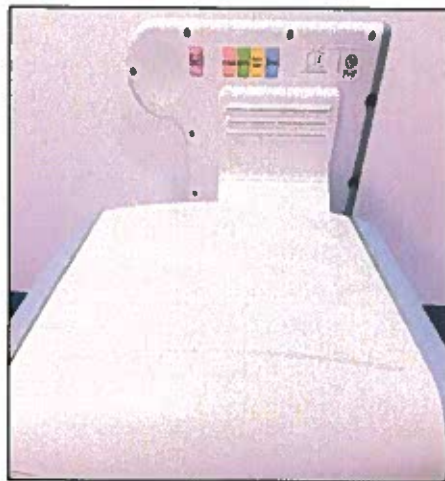
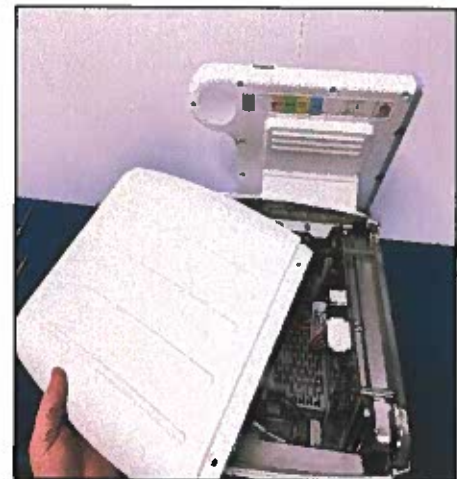
- a) Remove side and top covers from the ventilator to gain internal access to the UI Assembly's rear bezel retention bracket. (See **Figures 5 and 6**)

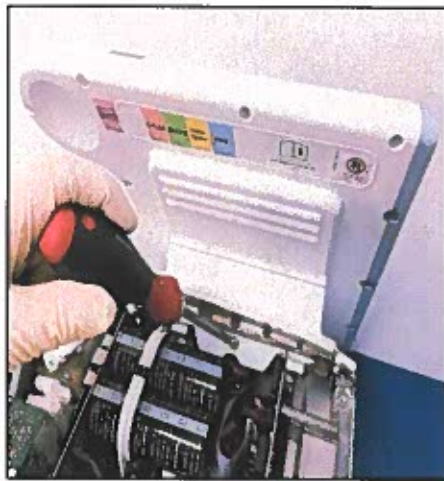
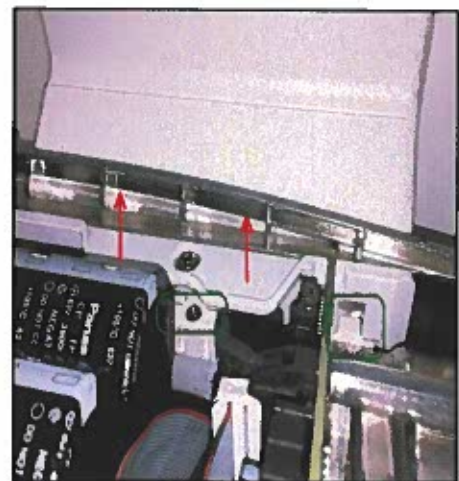
- b) Loosen the UI Rear Bezel retention bracket screw, taking care not to separate the captive nylon washer which keeps the screw captive to the bracket when the bracket is lifted to the unlocked (upward) position. (See **Figures 7 and 8**)

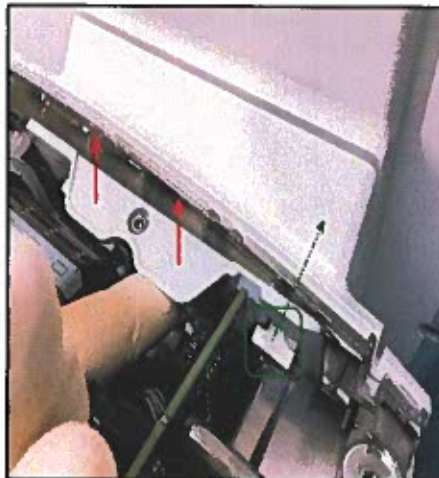
Figure 9

- c) Lift upward on UI Rear Bezel retention bracket to loosen the fingers of the UI rear Bezel from the retainer. The UI assembly can now be pulled away from the Front Panel enough to view its PN/SN label. (See Figure 9)

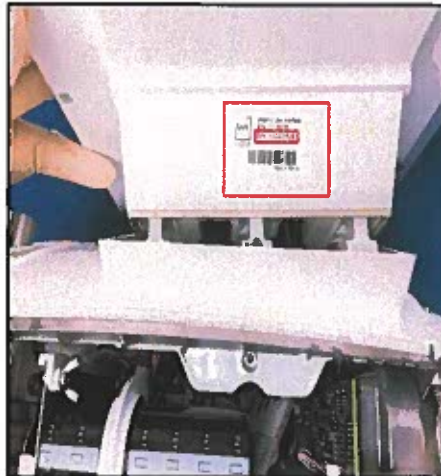
Figure 10

- d) Gently pull the UI Assembly away from the Front Panel just far enough to reveal its PN/SN and verify if the serial number indicated on its label, matches the serial number of the affected UI Assembly RP-Kit indicated in the **AFFECTED PRODUCTS** section above. (See Figure 10)

- f) If the serial number indicated on the UI Assembly currently installed in the ventilator **MATCHES** the serial number of the affected UI Assembly RP kit indicate in the "Affected Product" section, list the serial number of the **VENTILATOR** and the **UI Assembly** on the "Acknowledgement and Receipt Card" attached below. Upon receipt of the "Acknowledgement and Receipt Card," by Philips, appropriate action will be taken by a Philips authorized representative to replace the touchscreen in the ventilator containing the affected User Interface Assembly.
