Urgent: Field Safety Notice / FSCA 004-18

Affected device:

Product name	Reference number	Versions
IH-Com Fullversion	009000	5.1.7 and 5.1.10
IH-Com for Reader	009010

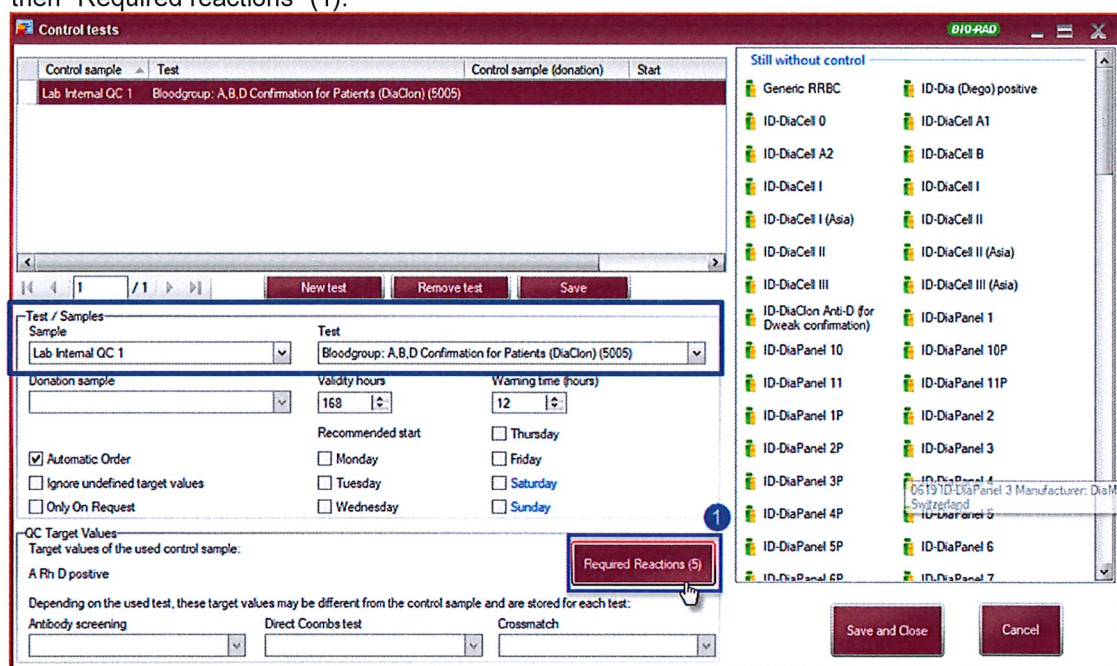
- I. A workaround exists and consists of manually defining the claimed reaction for the QC.
It must be applied as follows:
 1. Navigate to the settings "Control tests" in the QC module of IH-Com, select the test and the sample, then "Required reactions" (1):

2. Select the well by clicking on "+" (2), then click on the drop down menu (3) and choose the field name of the selected well (4).
