Ambu2015FA0001

## **Urgent Field Safety Notice**

**Ambu AuraGain**

**December 10, 2015**

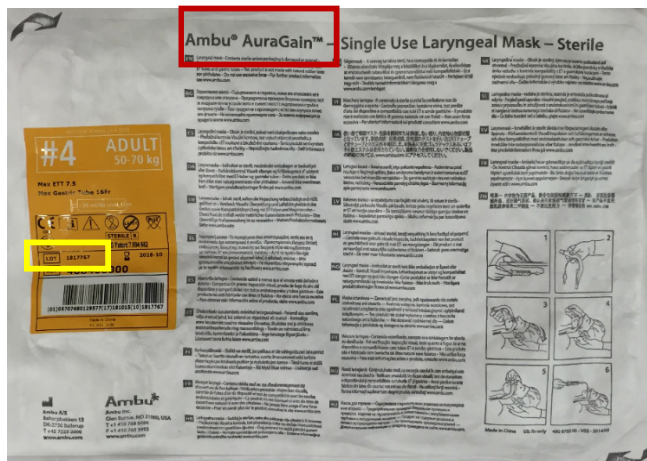
Please see picture to the right for positive identification of the device:

Note identification of device name highlighted with red box, and identification of LOT number highlighted with yellow box

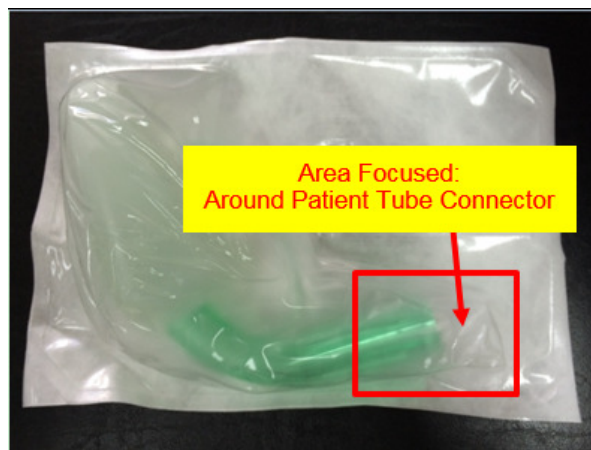
### Step 1:

The cause of the potentially compromised sterile barrier is a small hole in the transparent film. Please see picture to the right, for a visual specification of the area to inspect.

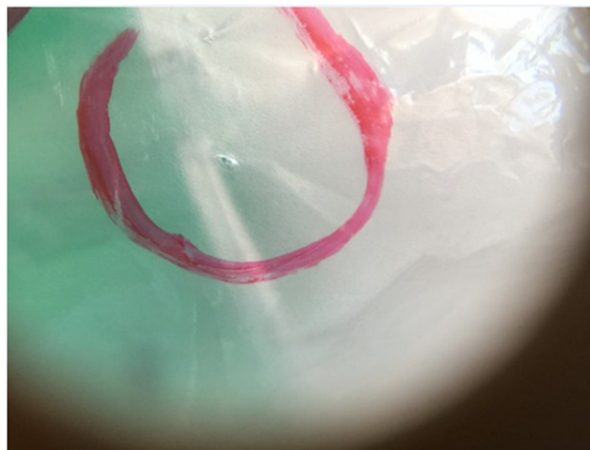
### Step 2:

The inspection should be carried out in a setting with good light, to support best possible identification of breach. The breach is associated with a mark in the transparent film. device has a mark like illustrated on the picture to the right, it should be discarded. If in doubt whether a specific device has a hole, please discard.

Discarded devices should be collected and quarantined. Information on discarded devices should be kept and filled into appendix 3.
