**URGENT FIELD SAFETY NOTICE**

**REF: FCA-123**

**Edwards Lifesciences LLC: Edwards Commander Delivery System Models 9610TF20, 9610TF23, 9610TF26, 9610TF29**

January 25, 2019

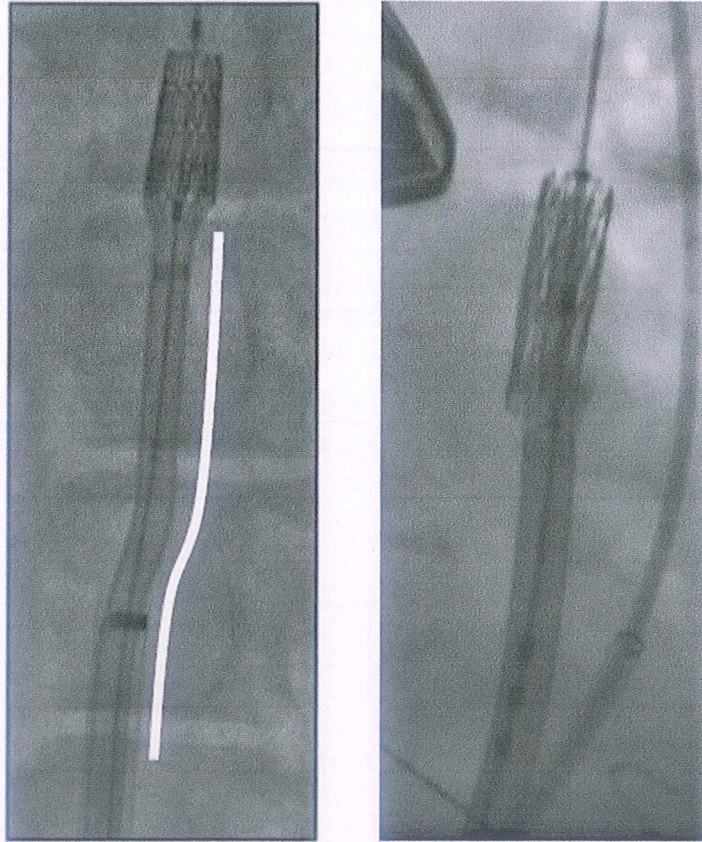
The illustrations from the physician's training manual are provided below (Figure 1) to illustrate instances of compression/ tension in the system during the procedure:

Figure 1: Delivery system flex shaft compression (Left) and valve diving (Right).

- Ensure there is no residual fluid left in the balloon during preparation and avoid overfilling the balloon during de-airing to prevent potential valve alignment difficulty.
- Execute valve alignment in a straight section of the aorta. Utilizing alternate fluoroscopic views may help with assessing curvature of the anatomy.
- If excessive difficulty is encountered when performing valve alignment, this may be an indication that alignment is being attempted in a non-straight section of the vasculature where alignment may not be safely achieved. In these cases, repositioning the delivery system to a different straight section of the aorta and relieving compression (or tension) in the system will be necessary (see Figure 1).

If maneuvers are not successful and severe difficulty is still encountered, discontinue attempts to align the valve in order to prevent device damage and remove the system as a single unit while maintaining guidewire position.
