Regulatory Affairs & Vigilance Department  
Toshiba Medical Systems Corporation

18-June-2016

### **Notice regarding modification to diagnostic ultrasound systems TUS-X200/X200S and TUS-X100**

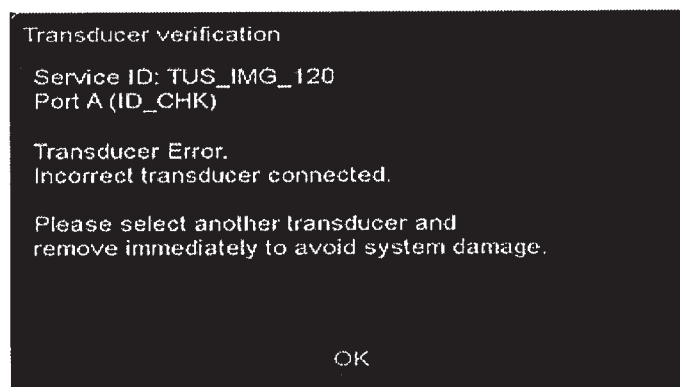
For the systems specified in section 1, an error message may be displayed due to the occurrence of a software error when a transducer is disconnected and reconnected, a transducer is changed, or another transducer is selected.

It has been found that when the following error message is displayed and the system continues to be used, the surface of the acoustic lens of the transducer may become hot, which can result in moderate burns if the transducer is used on one area of the patient's body for a long time.

<Figure> Display of error message

For the problem described above, software containing corrective measures will be installed as modification support.

If the error message shown in section 3 is displayed before the modification has been performed, immediately stop using the system and perform the procedure described in steps 1) to 4) below to check the problem.

The system can be used with no problem if the error message shown in figure 2 is not displayed. If the error message is displayed again even after performing the procedure described in steps 1) to 4), it is likely that the system or the transducers are faulty. In this case, contact your service representative.
